Re: Estimate Wilton Cemetery Paths

Asbestos Management Survey
Public Toilets
Greyhound Lane
Wilton
SP20BD

Date: 11th June 2025 Expiry Date: 11th June 2026 Prepared by K Howell Reviewed by C Jelfs

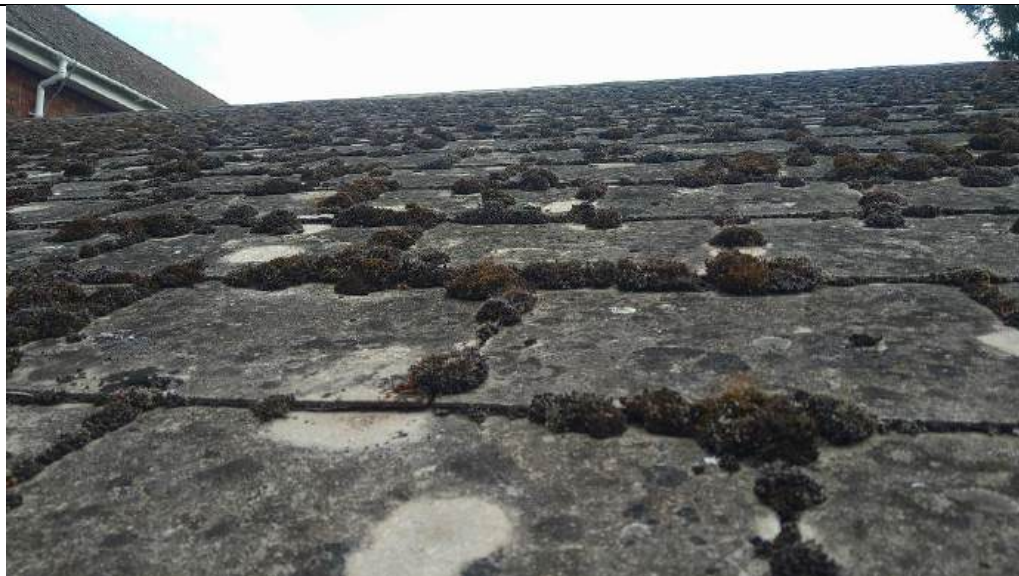
Client			
Survey Address	Public toilets, Greyhound Lane, Wilton, SP20BD		
Location/Item	E01 Externals/Asbestos cement Roof Tiles		
Reference Number	Ref 2		
Sample Number	002		
Photo Details

Risk Matrix			
Asbestos Type	1	Product Use	1
Condition	1	Surface Treatment	1
Material Risk		Action	Mark & Manage
Priority Assessment			
Accessibility			
Amount/Extent	60M2		
Surveyors Notes	To Roof

Floor	Area No.	Area Description	Sample Number/Item Reference	Material Description & Location	Average Scores				Product Type 1, 2 or 3	Damage 0, 1, 2 or 3	Surface Treatment 0, 1, 2 or 3	Asbestos Type 0, 1, 2 or 3	Risk Score	Recommendation Mark and Manage Encapsulate Remove Exercise Caution	Action Date
					Activity within Area 0, 1, 2 or 3	Likelihood of Disturbance 0, 1, 2 or 3	Human Exposure Potential 0, 1, 2 or 3	Maint Activity 0, 1, 2 or 3							
G	001	Gents Toilets	Sample 001/Ref 1	IB Ceiling											
G	002	WC													
G	003	Ladies Toilets													
1	E01	Externals	Sample 002/Ref 2	Cement Roof Tiles					1	1	1	1	4	Mark & Manage	11/6/2026

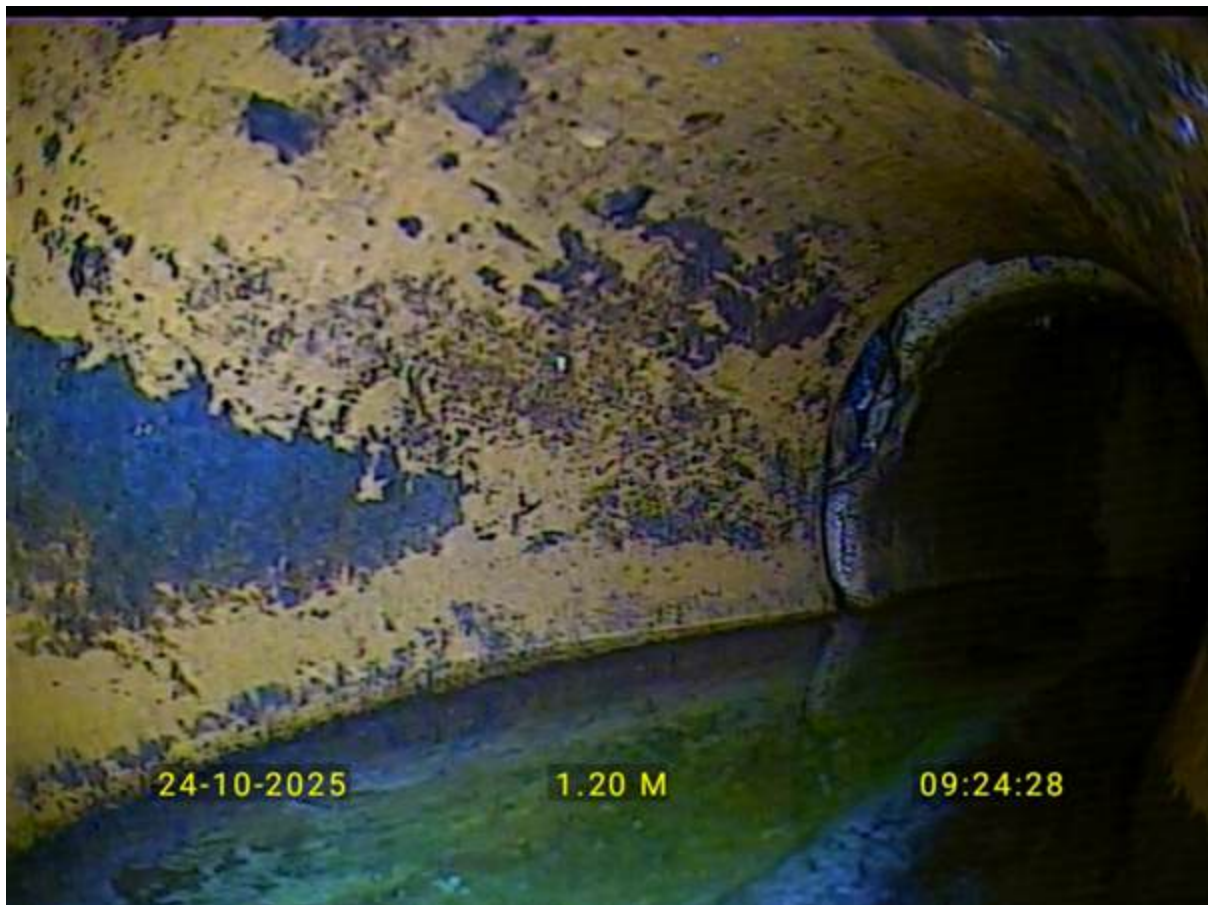
There were some misaligned joints and standing water in the disabled pipe run, which may point to insufficient fall.

The current foul drainage system is in a reasonable condition but will require some minor work to be undertaken. Initially the system will require high pressure jetting to remove the scale build up to ensure a smooth run through the pipe runs preventing waste and tissue catching and reducing the chances of blockages. To prevent major excavations to be undertaken, lining of the pipes could be carried out where required to seal the misaligned sections and generally strengthen the system.

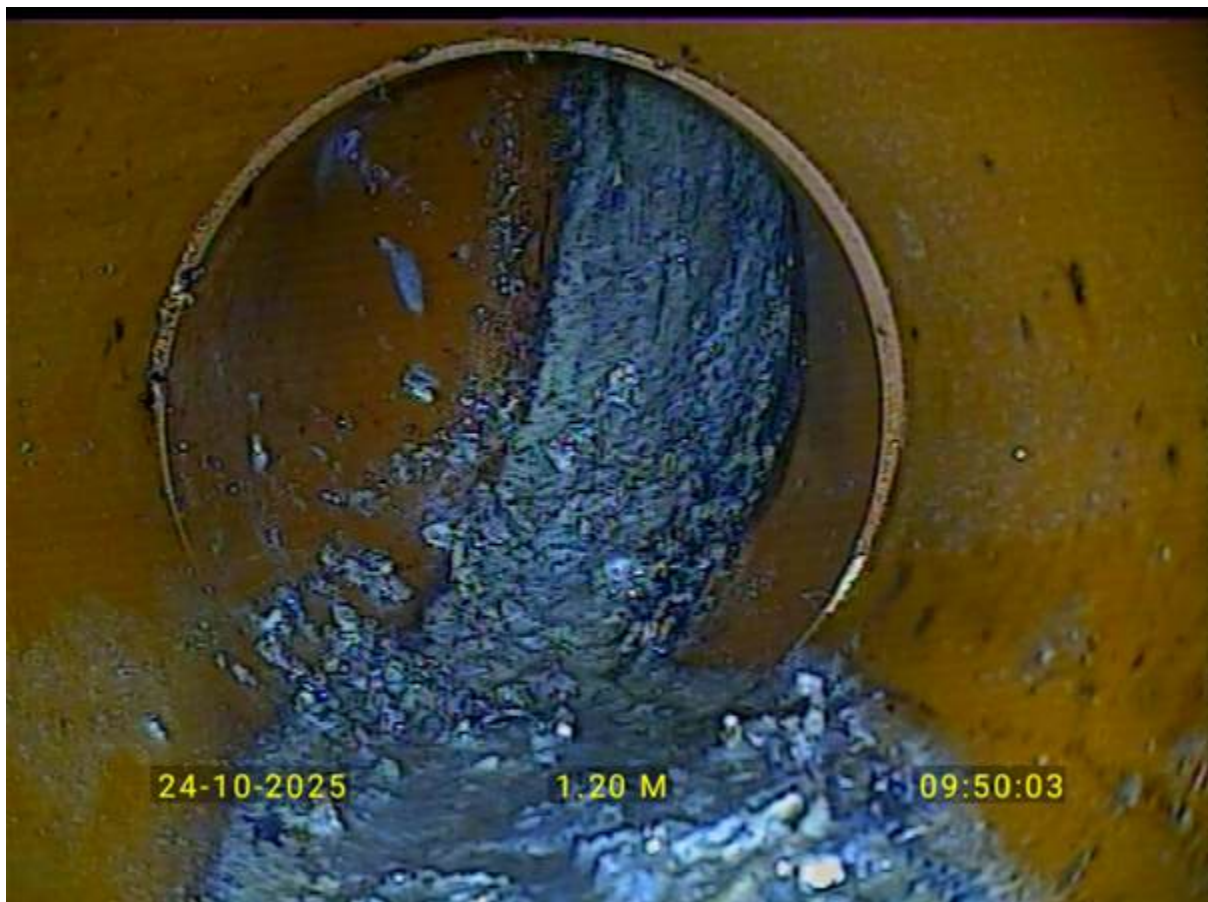
Scale in urinal pipe

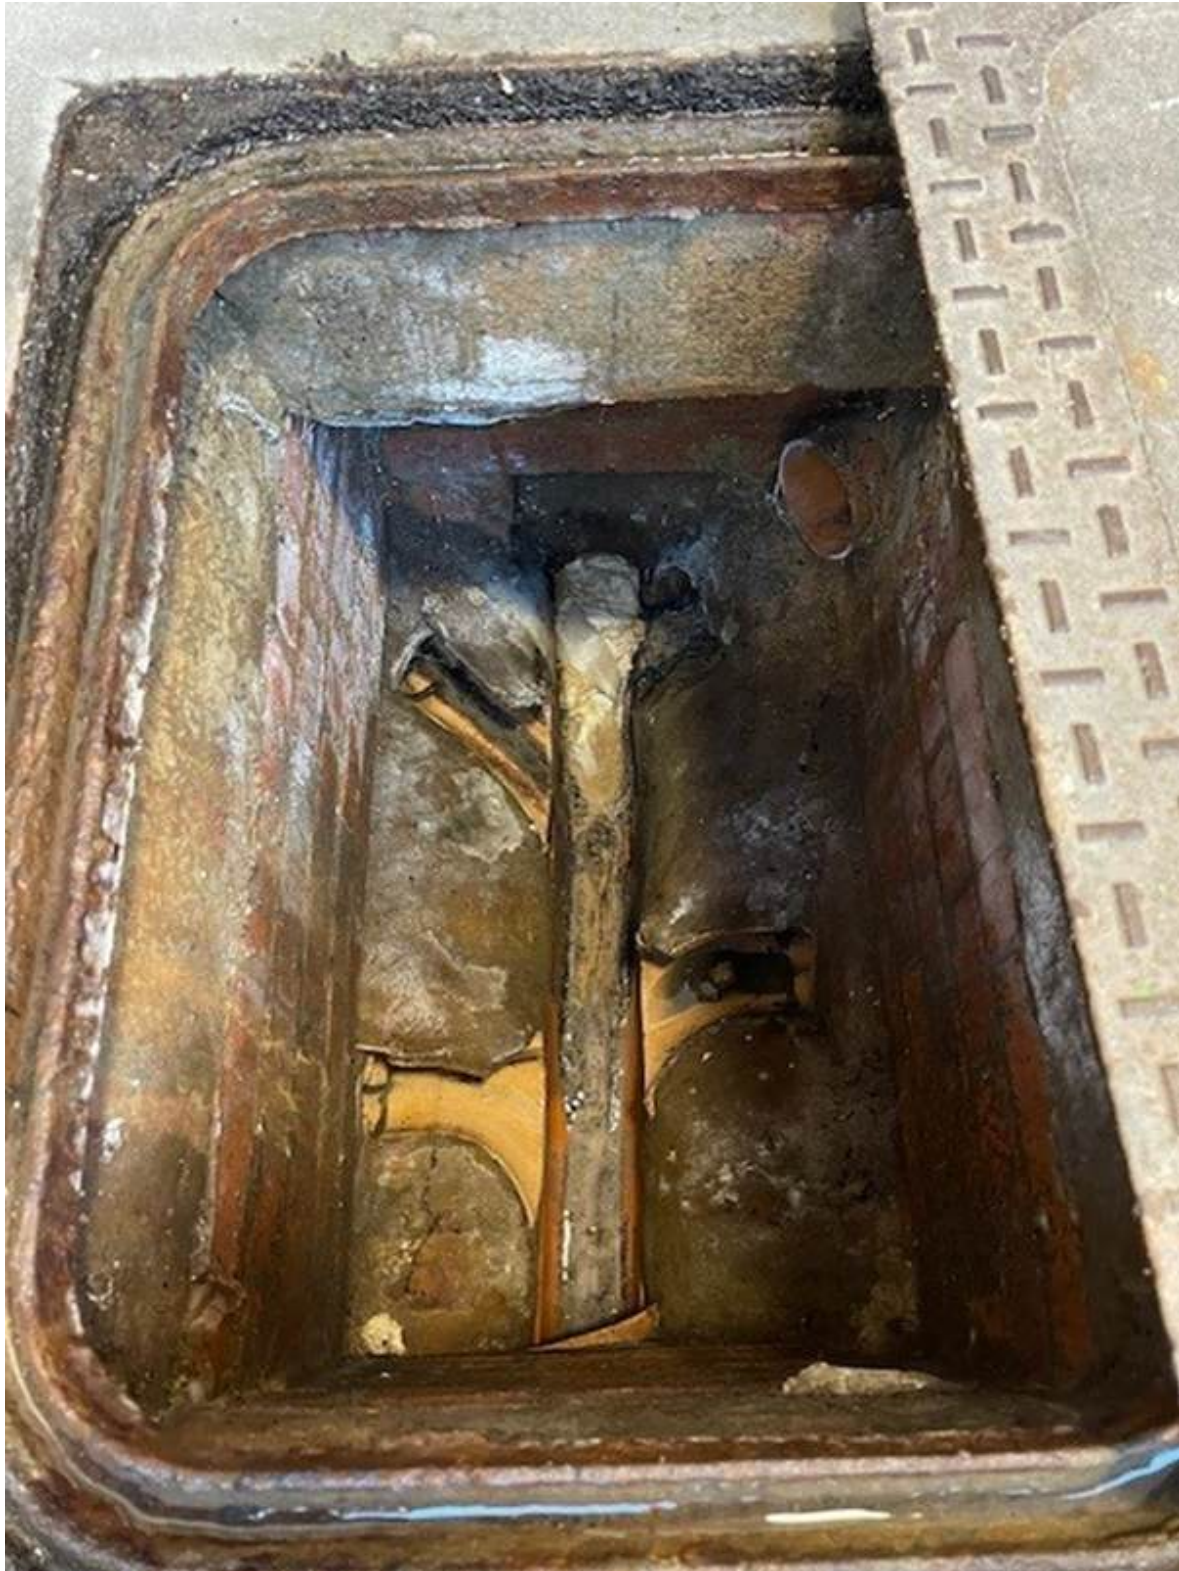
Inspection Chamber with blockages

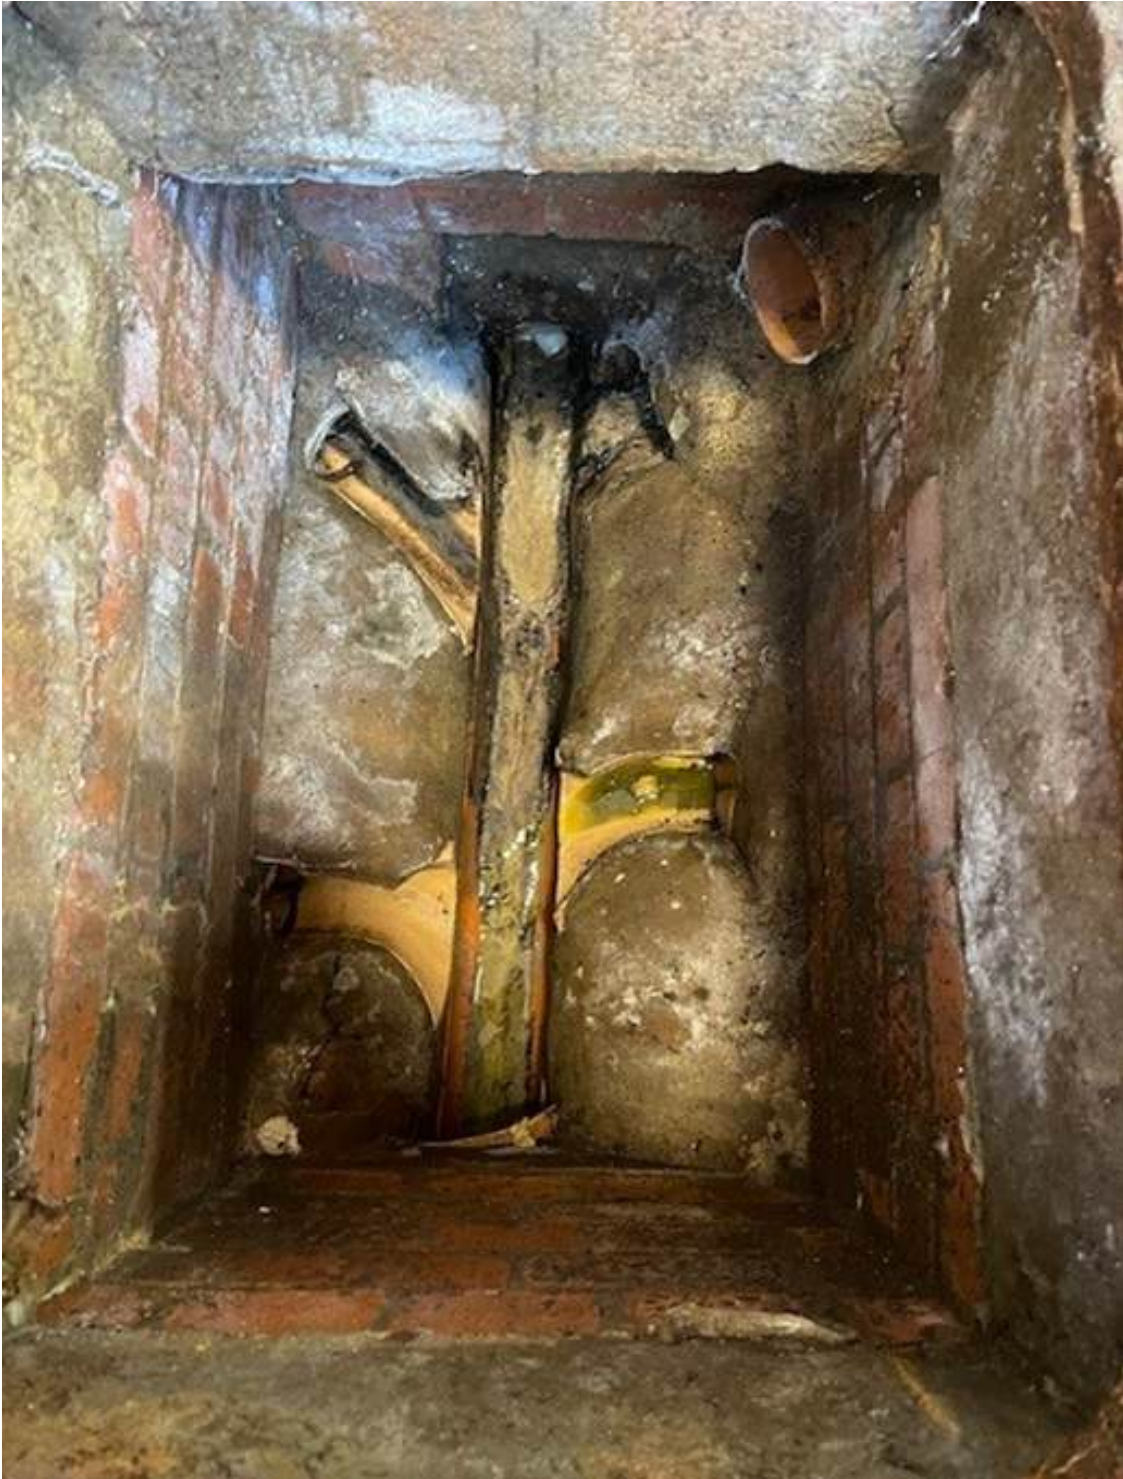
Blockage clear and showing heavy scale

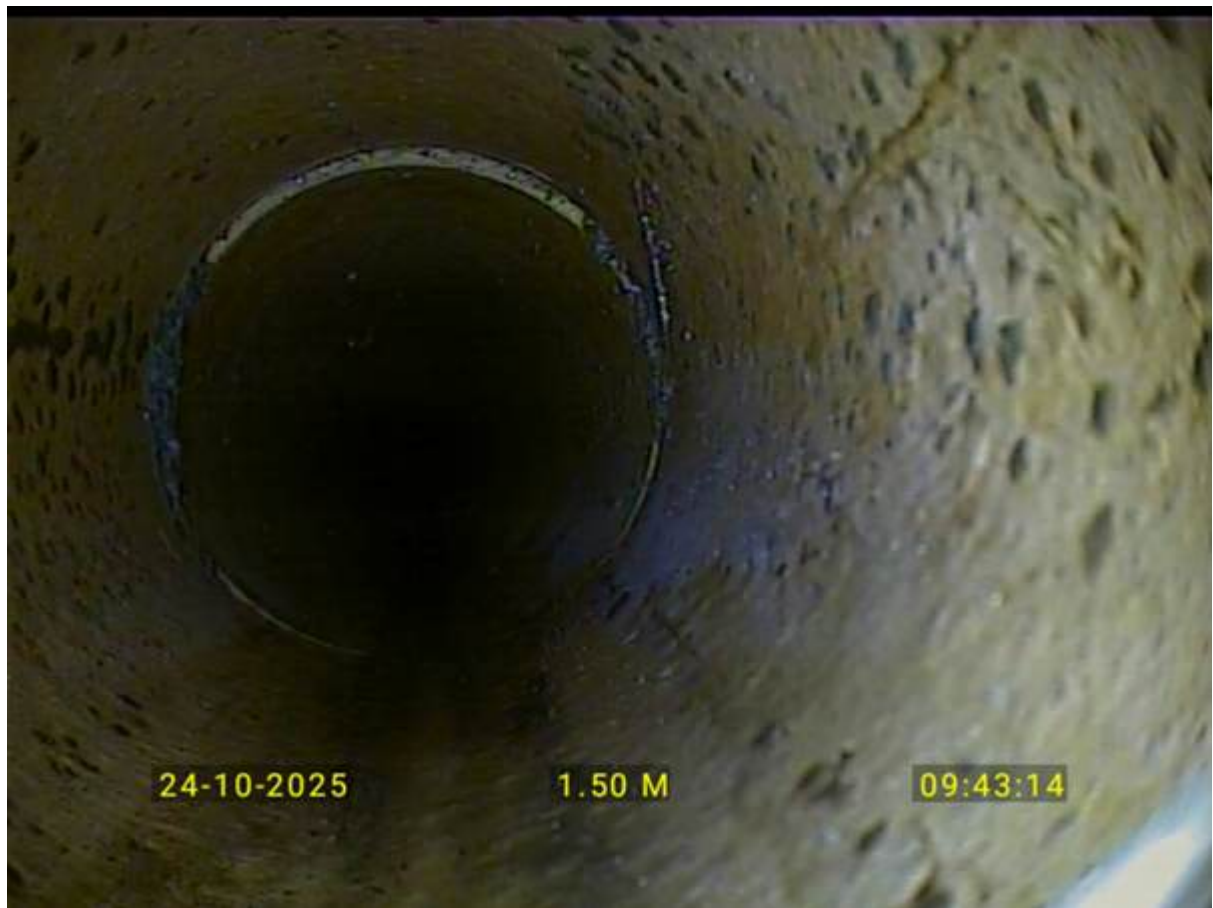
Minor misalignment on gents basin run

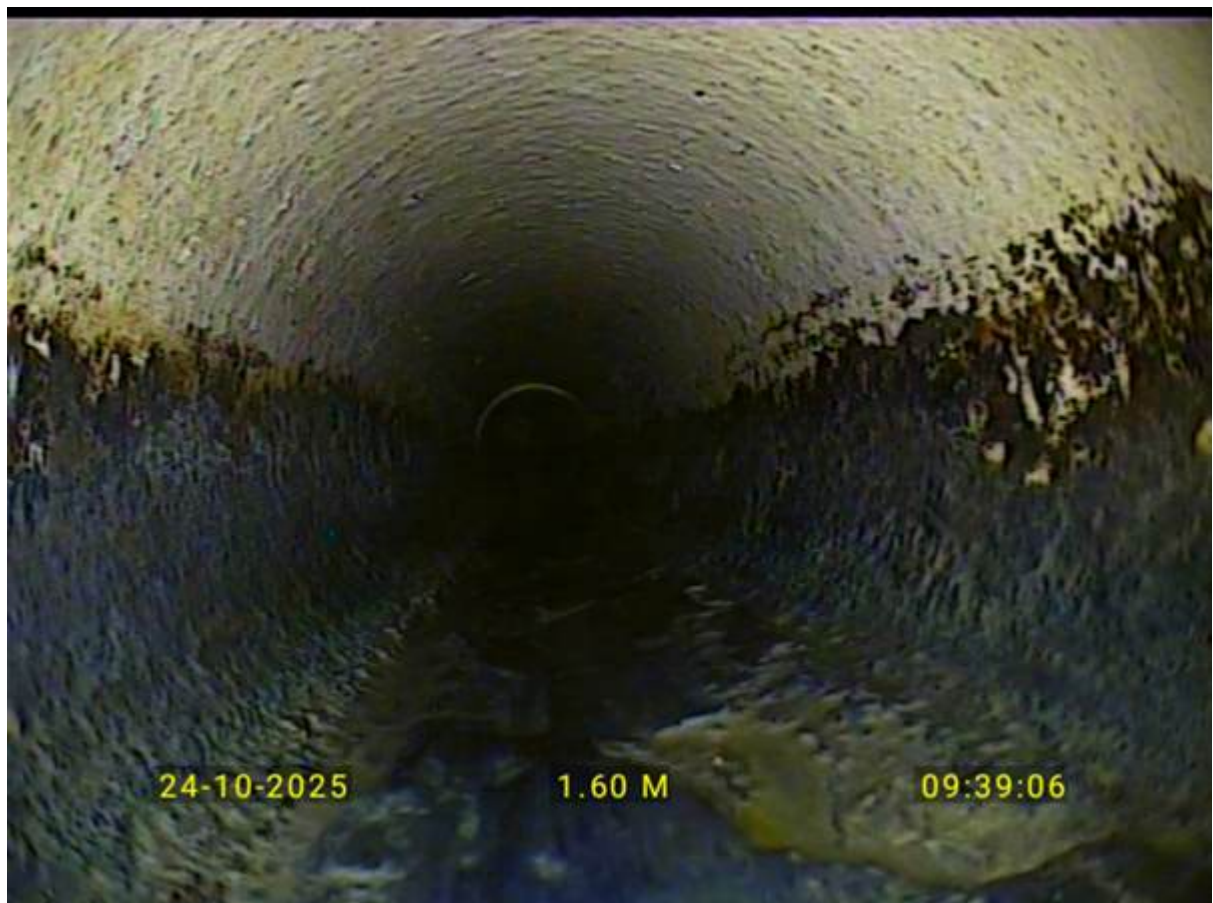
Heavy scale on urinal pipe run

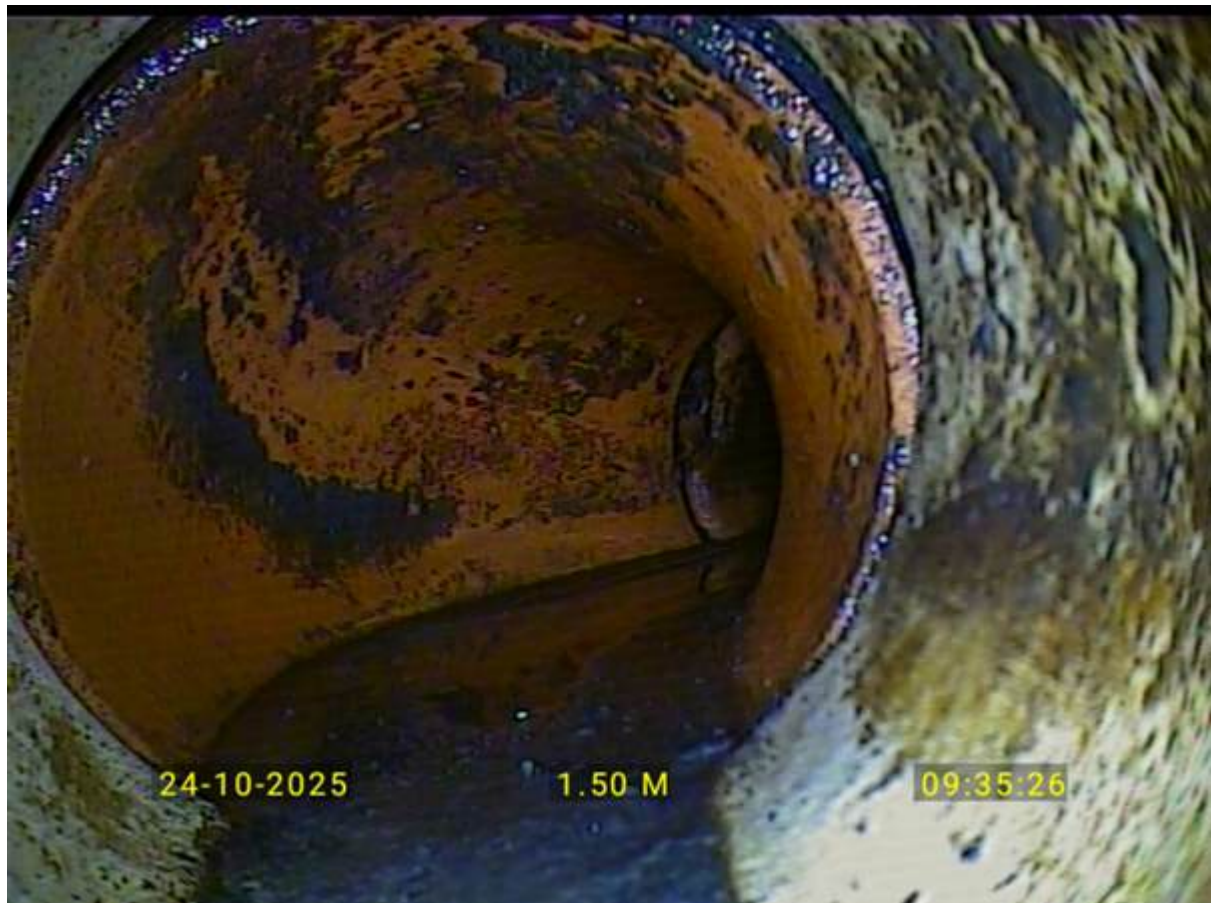
Misaligned pipe with standing water in disabled/ladies

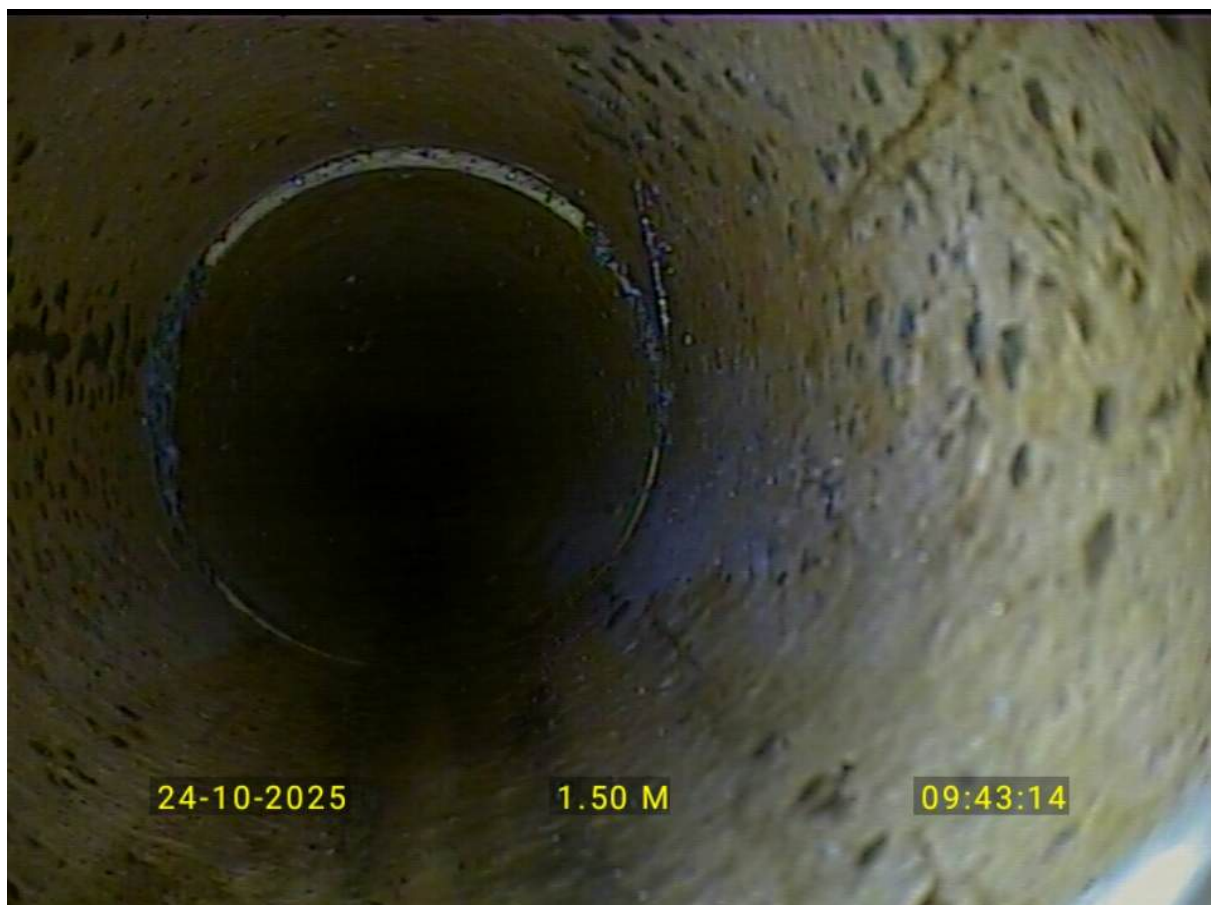
Misaligned pipe on gents basin run

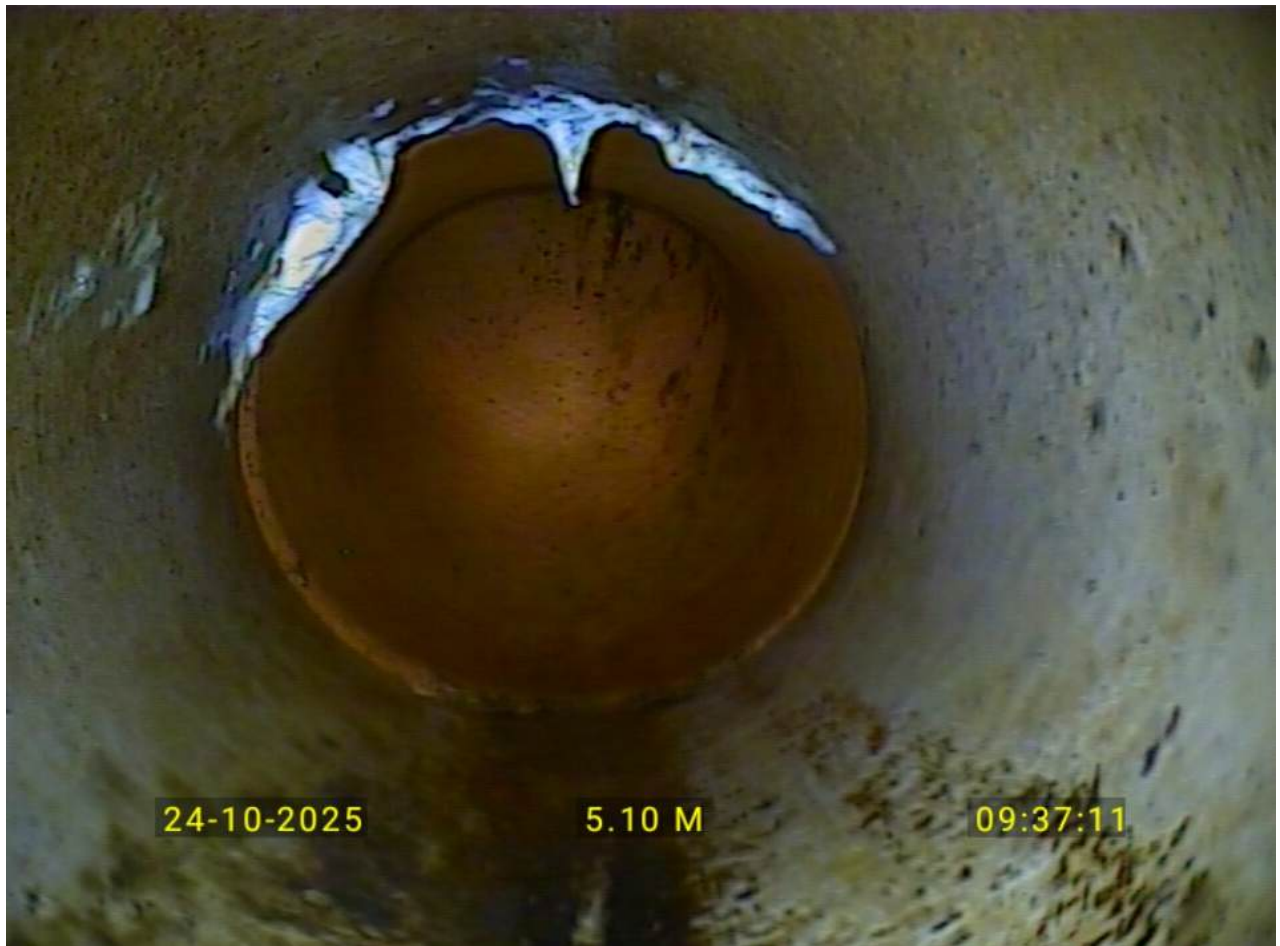
Misaligned joint in gents toilet line

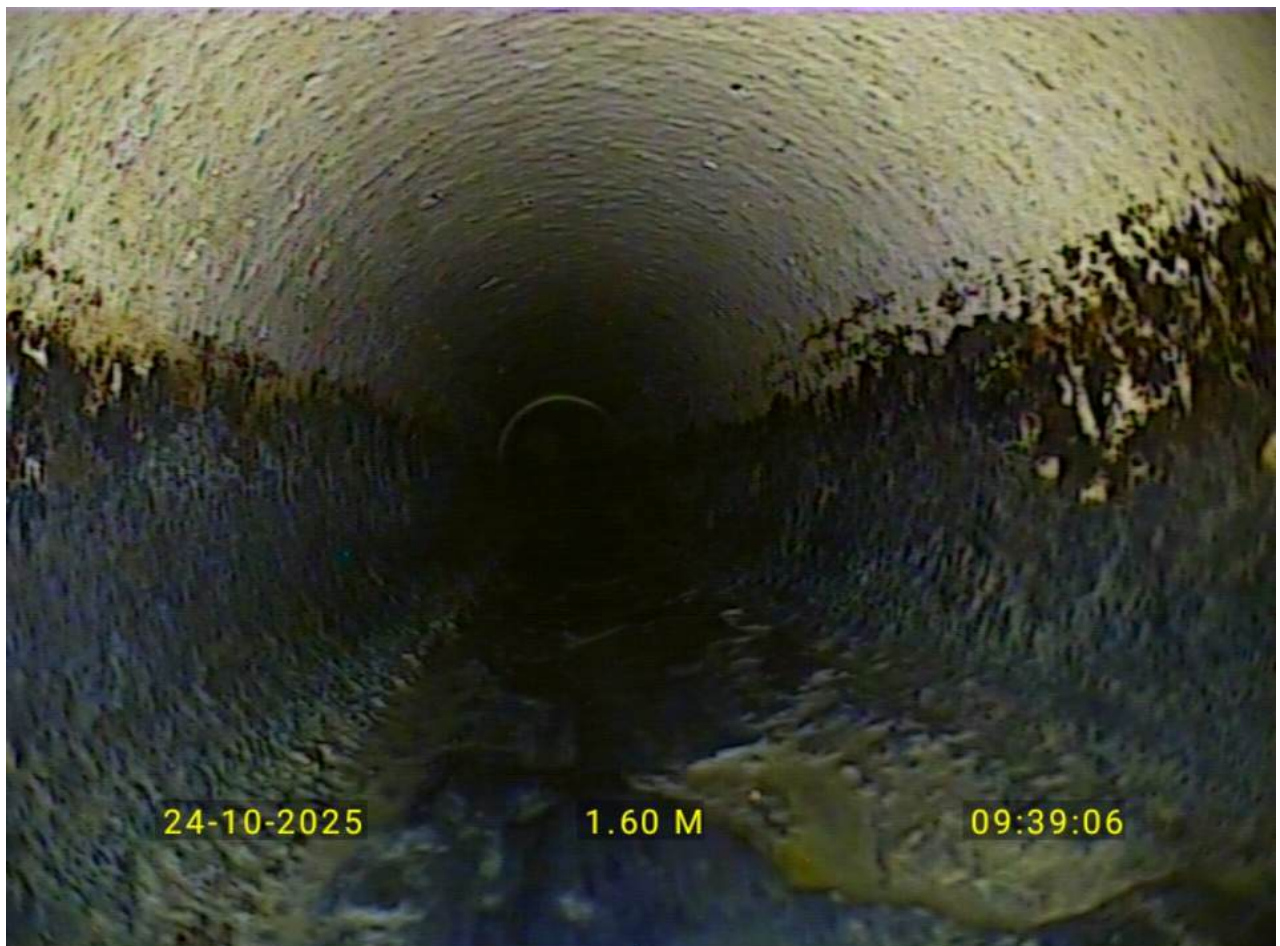
Scale build-up shown in gents toilet run

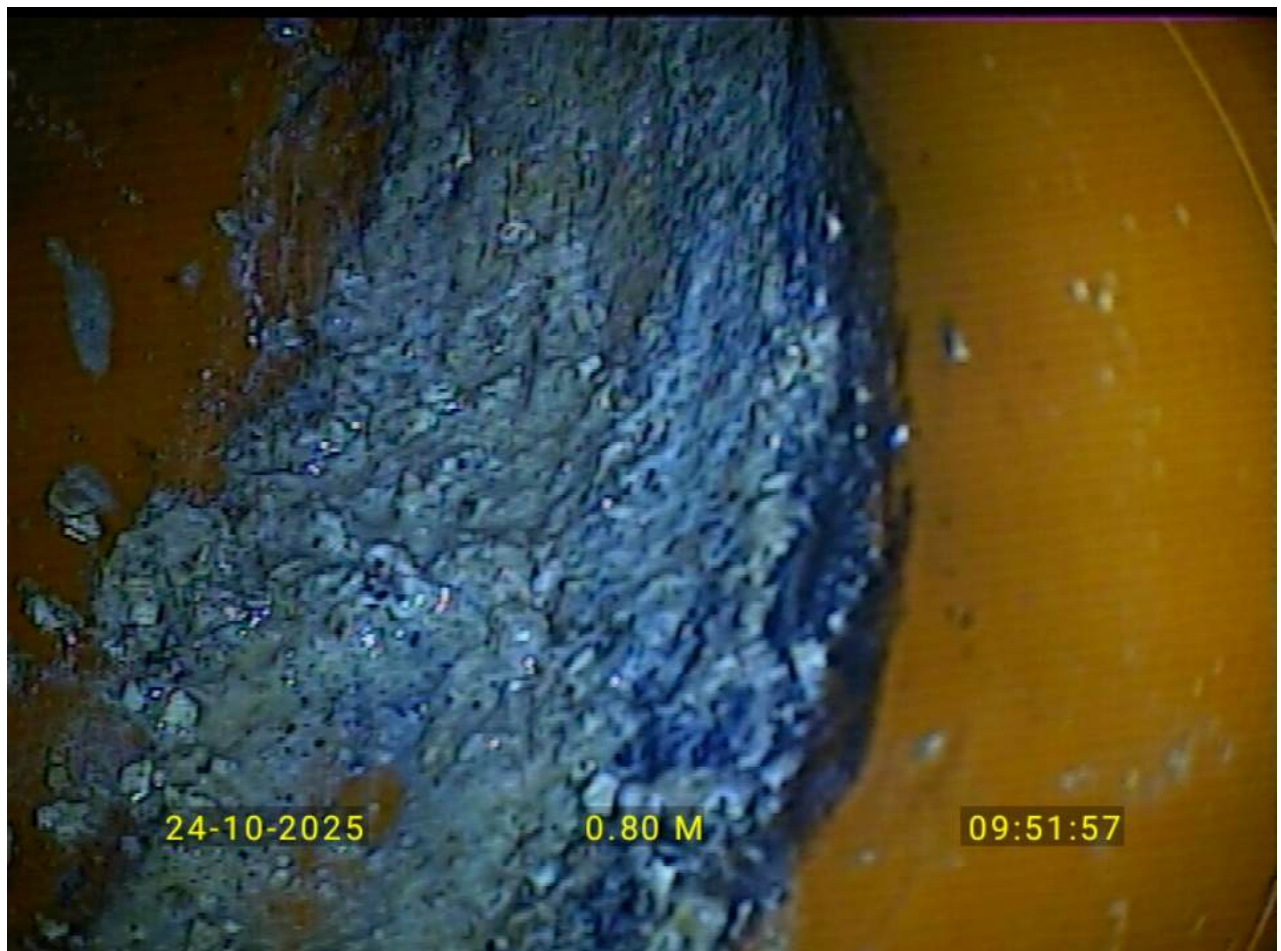
Urinal run - Unable to pass
