## **Asbestos Demolition/Refurbishment Survey**

**Public Toilets  
Greyhound Lane  
Wilton  
SP20HT**

**Date: 29/10/2025**

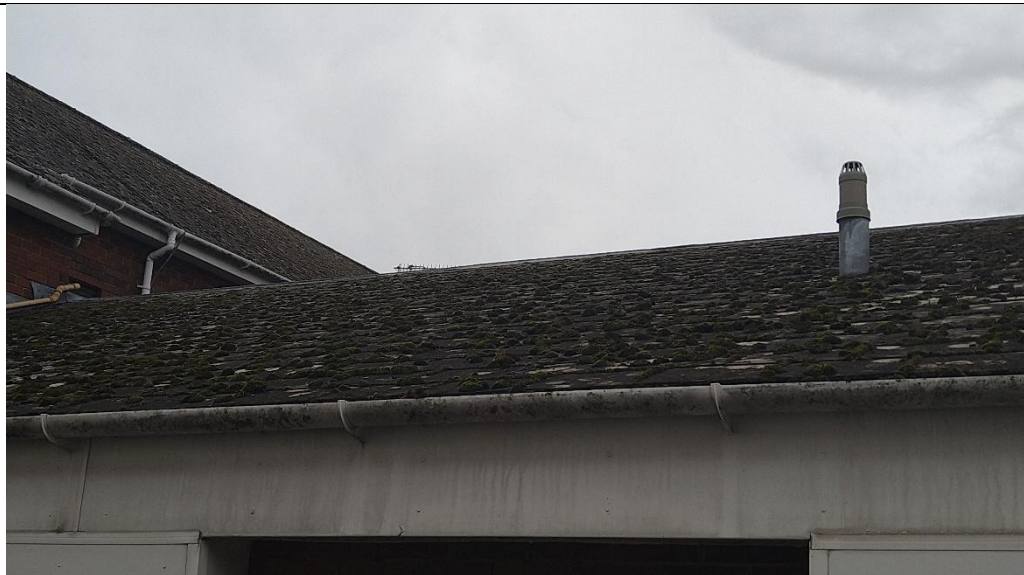
Client			
Survey Address	Public Toilets, Greyhound Lane, Wilton, SP20HT		
Location/Item	E01 Externals/Asbestos Cement Roof Tiles		
Reference Number	2		
Sample Number	2		
Photo Details

Asbestos Type	1	Product Use	1
Condition	1	Surface Treatment	1
Material Risk	4	Action	RIA
Accessibility	Low		
Amount/Extent	65M2		
Surveyors Notes

Remove Asbestos If Affected by Refurbishment Works

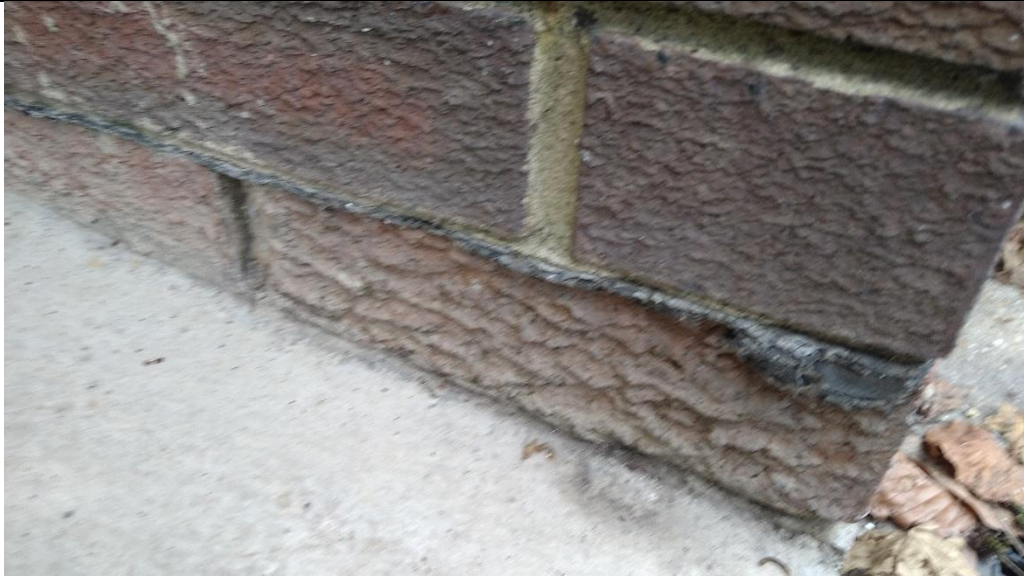
<b>Client</b>			
<b>Survey Address</b>	Public Toilets, Greyhound Lane, Wilton, SP20HT		
<b>Location/Item</b>	E01 Externals/Asbestos Damp Proof Course		
<b>Reference Number</b>	4		
<b>Sample Number</b>	4		
<b>Photo Details</b>

<b>Asbestos Type</b>	<b>1</b>	<b>Product Use</b>	<b>1</b>
<b>Condition</b>	<b>1</b>	<b>Surface Treatment</b>	<b>1</b>
<b>Material Risk</b>	<b>4</b>	<b>Action</b>	<b>RIA</b>
<b>Accessibility</b>	<b>Low</b>		
<b>Amount/Extent</b>	<b>Footprint of Building</b>		
<b>Surveyors Notes</b>

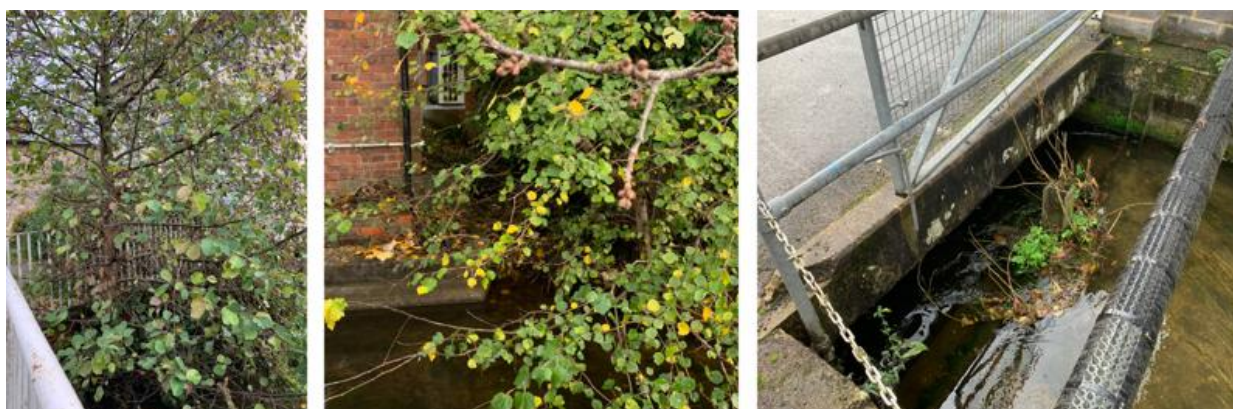
Further upstream along Crow Lane, a high flow channel was observed. This channel was likely originally designed to convey flows during high water or flood events. However, during the site visit, it was noted that the channel is heavily obstructed by debris, vegetation, and tree growth at its downstream end where it connects with the main channel. These blockages are likely to limit its hydraulic capacity and effectiveness during flood conditions.

A redundant weir was observed in the Crow Lane area, causing an accumulation of debris upstream. This obstruction is creating a localised difference in water levels of approximately 100mm. The weir no longer serves a functional purpose and is contributing to an increased flood risk by allowing debris to collect, which could exacerbate flooding to surrounding areas during high flow events. Removal or modification of this structure is recommended to restore natural flow and reduce associated risks.

Figure 2: Images left to right. Road bridge adjacent to Crow lane, Crow lane High level channel blocked, Crow lane redundant weir.

Based on the observed risks, including vegetation encroachment at the bridge, blockage of the high level channel, and debris accumulation around a redundant weir. It is recommended that regular vegetation management be undertaken, with overhanging and channel vegetation, particularly alder trees near the bridge, routinely trimmed or removed to maintain unobstructed flow.

A scheduled maintenance programme should also be implemented to minimise debris build up. The high level channel should be cleared of accumulated debris, trees, and invasive vegetation to restore its intended hydraulic capacity during flood conditions.

In addition, the redundant weir should be modified or removed to re-establish natural flow conditions and reduce upstream water level variation, ensuring that all removed material is safely disposed of and monitoring is carried out for any downstream sediment movement.

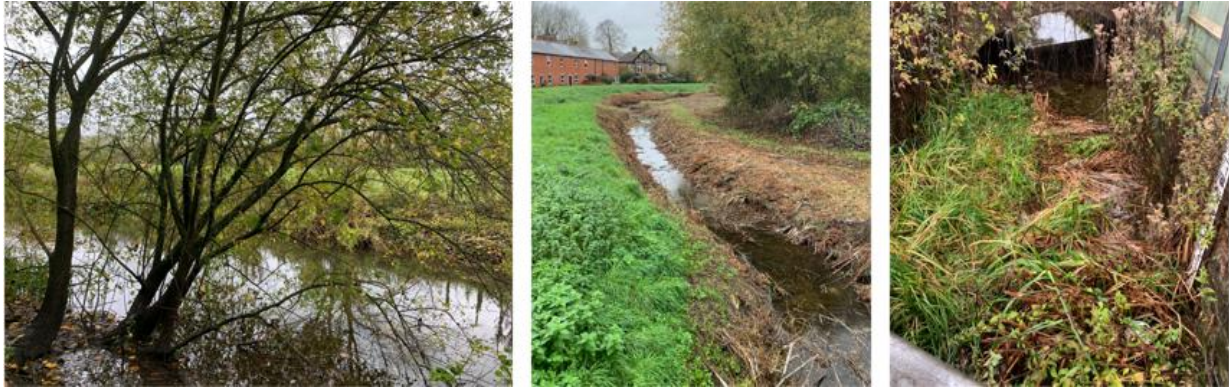
During the walkover at Wilton Meadows, several medium to large willow trees were observed along the banks of the River Wylfe. These trees pose a potential future risk of falling into the channel and becoming established within the watercourse, which could restrict flow and reduce channel capacity. While a limited amount of fallen or marginal vegetation can provide ecological benefits and does not significantly impact flow, ongoing maintenance will be required to prevent excessive accumulation of fallen trees or debris that could lead to blockages.

Further downstream, an artificially created high flow relief channel designed to run adjacent to Wiley Ter was found to have little to no observable flow. This lack of movement is likely due to a downstream obstruction identified later in this report, a weir with an abnormally high crest level. The gradient of the tributary is minimal, and dense vegetation growth within the channel further contributes to the reduction of flow velocity and conveyance.

Downstream of the road bridge adjacent to Wiley Ter, vegetation has become established across the full width of the channel due to prolonged low flow conditions. This excessive growth is restricting flow, reducing conveyance capacity, and increasing the risk of localised flooding during high water events.

Figure 3: Images left to right. Wilton Meadows Overhanging Willow, Wiley Ter high flow channel, Downstream of Wiley Ter

Medium to large willow trees could fall into the channel, causing blockages and restricting flow and potential for future bank destabilisation if root systems fail or trees topple.

Given the observed risks overhanging willow trees, reduced low flow capacity in the relief channel due to a high downstream weir, and vegetation growth restricting flow downstream of the bridge. It is recommended that a proactive tree management approach be adopted, involving the monitoring and selective pruning or removal of medium to large willow trees to prevent potential blockages while retaining ecological value through a structured maintenance plan.

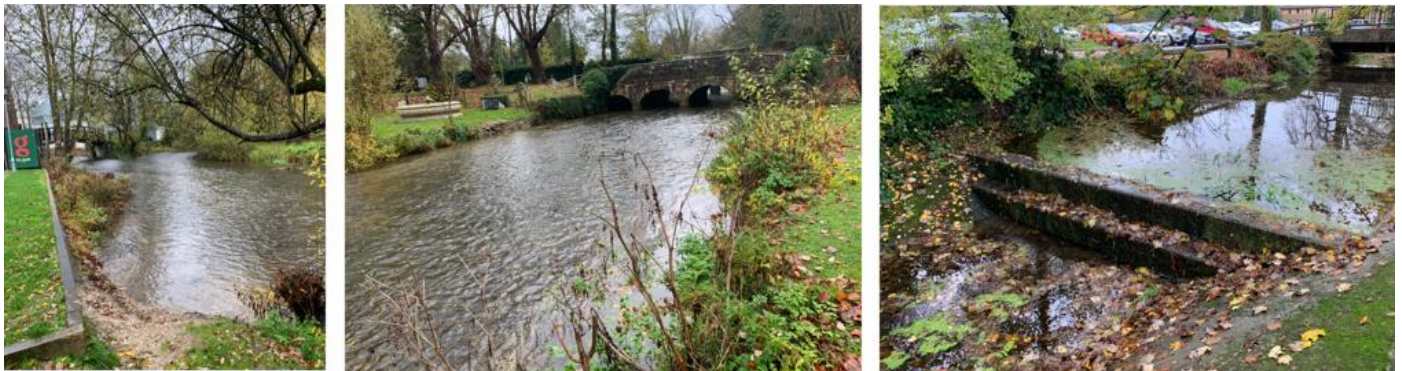
Upstream of the Guild Shopping Centre entrance, debris was observed within the river channel, along with localised areas of bank erosion. These erosions correspond with the remnants of a previously installed revetment, which has deteriorated, leaving only some upright posts in place.

Further downstream, towards the A30, similar patterns were observed. The original revetment has largely diminished, and additional erosion along the banks has been caused by wildlife, public access, and domestic animals. Several willow trees are also establishing along the banks; these will require management to prevent them from dominating the channel margins and further restricting flow.

The connecting channel from Wiley Terrace contains a substantial weir, approximately 800mm in height, which significantly restricts downstream flow. This obstruction results in minimal water movement in the channel, causing debris and sediment to accumulate. Consequently, the restricted flow increases the risk of flooding to upstream properties during high flow events. Addressing this area presents a key opportunity for flood alleviation and improving overall channel efficiency.

Figure 4: Images left to right. Wilton Guild Shopping centre, River Wylfe upstream of A30 Road Bridge, Weir on River Wylfe Channel from Wiley Ter.

Localised erosion of banks reduces channel stability and may contribute to sedimentation downstream, along with remnants of deteriorated revetment provide limited protection, increasing risk of further bank failure.

Putting into account current observed risks, including debris accumulation, bank erosion with diminished revetments, the establishment of willow trees, and a substantial weir restricting flow. It is recommended that bank stabilisation works be undertaken, repairing or replacing degraded revetments with environmentally sensitive solutions such as bioengineering, pre planted coir rolls, or rock rolls (however have plastic content for the material used to contain the granite rocks), while also introducing protective measures to limit damage from wildlife, domestic animals, and public access.
