# Tree Risk Assessment 2026

For two trees on at St. Mary's Church in Wilton

Inspected and Prepared by Nick Baxter BSc(Hons) MArborA  
16<sup>th</sup> March 2026

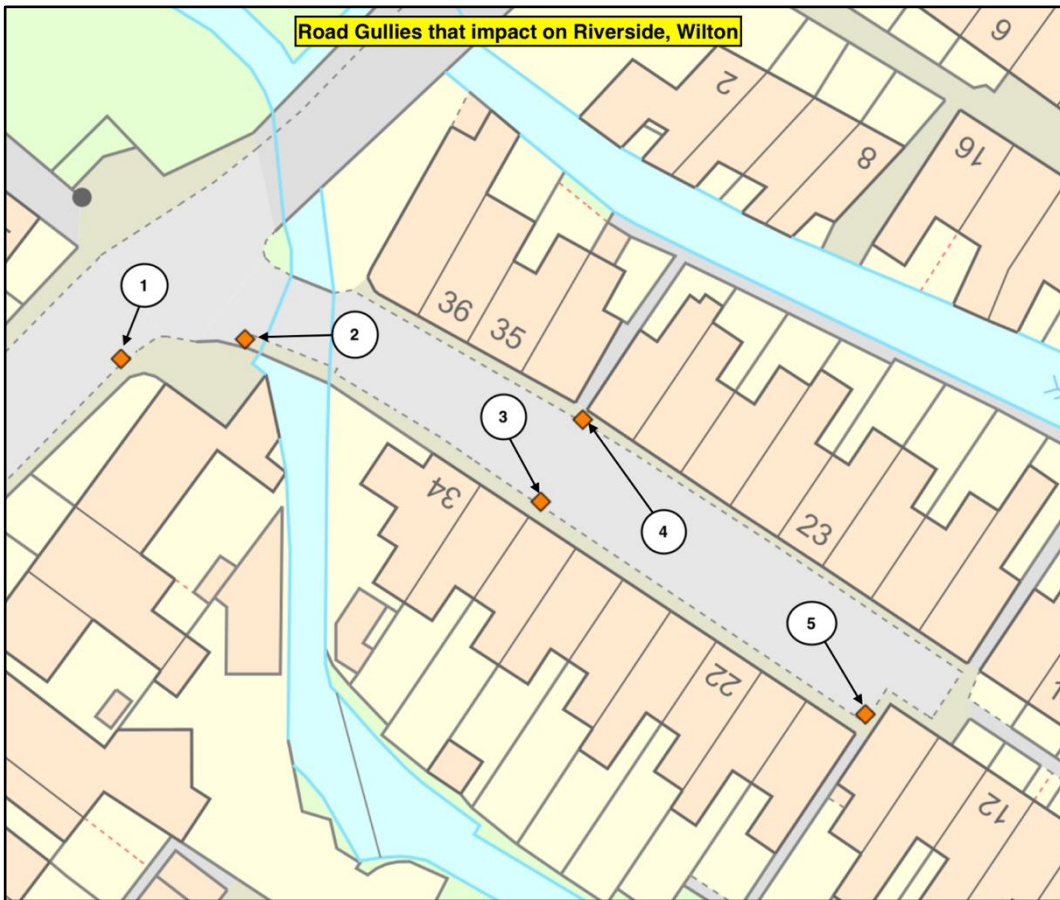
There are 3 drains in Riverside that are fully blocked and 2, one that on the edge of North Street and the other at the entrance to Riverside are partially blocked. These are shown on the map below.

Currently this is the area at most risk of flooding assuming the Environment Agency Barrier has been deployed in Crow Lane.

Note: No.5 is at the lowest point on the road

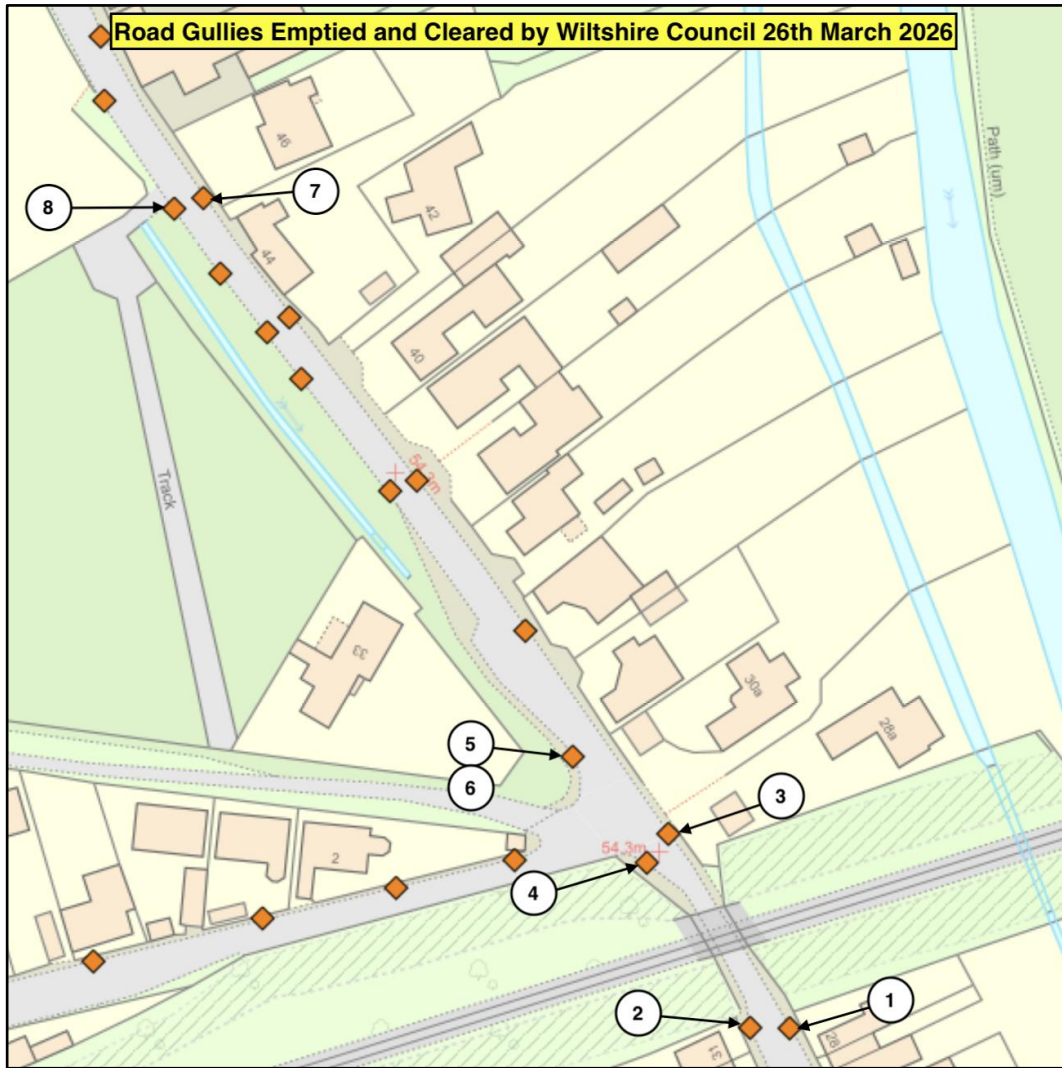
Note: Gullies 7 & 8 these have their own discharge pipes with outlets which discharge into the ditch. Both these discharge pipes were blocked with silt.

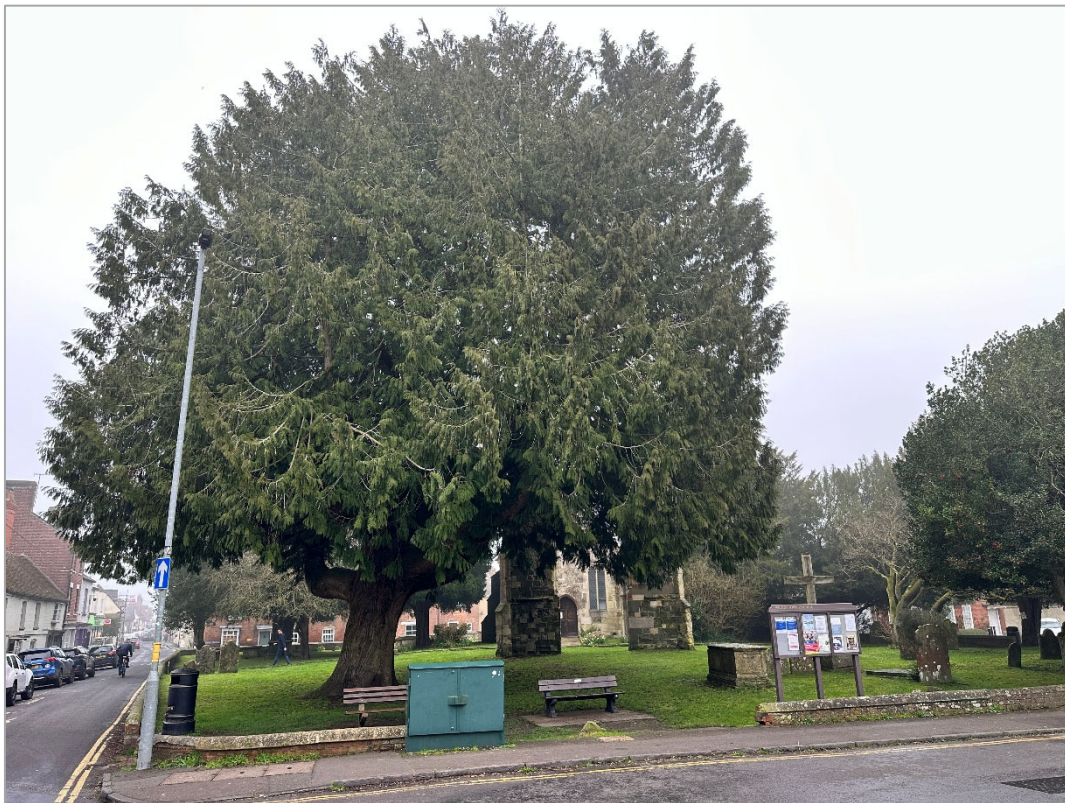
Figure 2: T1 – Western red Cedar

This tree has several surface roots with damage to the upper sides from lawn mower use. There are numerous large healthy buttresses on all sides, and several large limbs extend from below 6m. One limb on the south side of the canopy has an old wound on its upper side, however this has years of healthy wound wood present. There is minor deadwood present but only over a low-use area. The whole tree has had a past crown lift to approximately 4m.

It is my understanding that this tree is decorated with Christmas lights during the festive season, and that Wilton Town Council would like to explore options for management to improve its appearance for that time. The tree has a particularly wide canopy that has been crown-lifted to allow access beneath it, and it also has a rounded upper crown. In contrast, a typical Christmas tree has a narrower canopy that extends to ground level and features a distinctive apical leader at the top. In my opinion, it is for these reasons that the tree does not appear as visually impressive during the Christmas season as might be hoped. Achieving the desired shape would require significant pruning; however, this would not be feasible for this species because there is very little internal growth to retain. Such pruning would likely result in an unattractive appearance and could also reduce the tree's longevity. Furthermore, the extent of pruning required would not receive approval from a local authority tree officer.

In this instance, no remedial works have been recommended, nor are any works considered realistic to improve the appearance of the living Christmas tree.

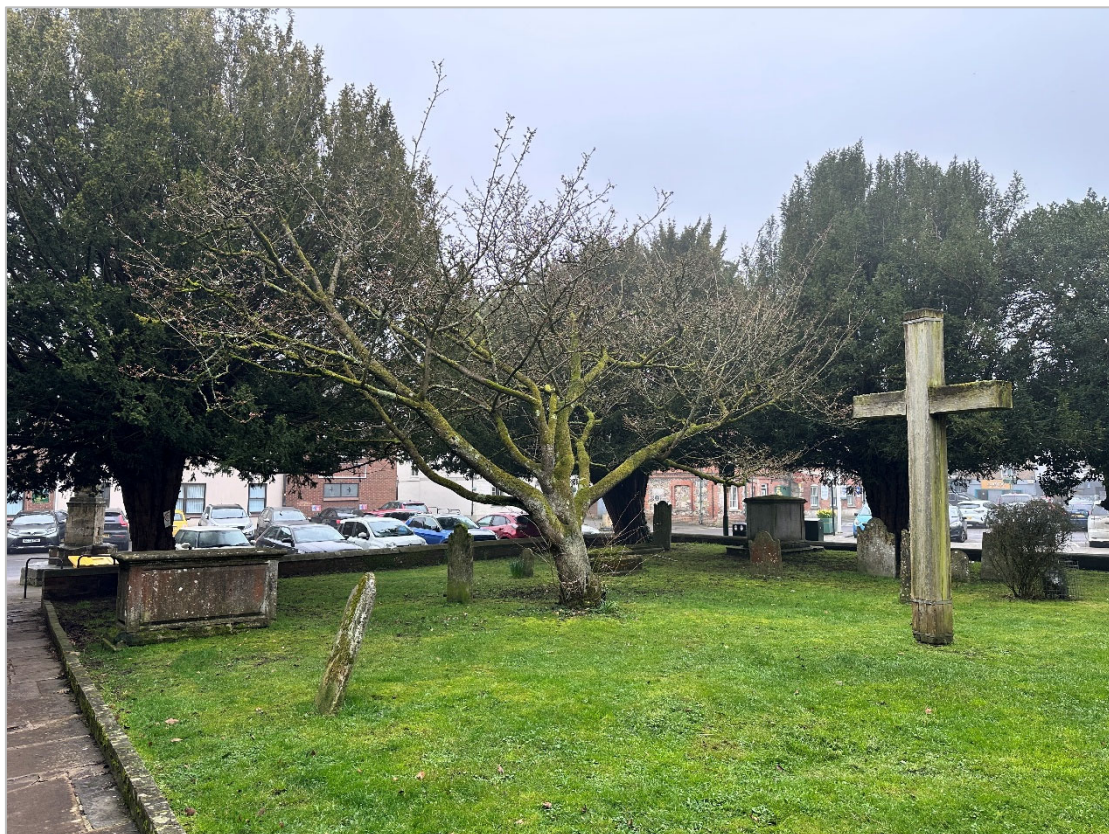
Figure 3: T2 - Cherry

This tree has a large pruning wound at the base with associated decay. The whole crown is asymmetric, leaning east into the adjacent yew trees. One low stem extends south-east and the remaining crown extends north-east. The whole crown has once been reduced but only the southern side has re-grown since light is better in this space. Overall, given its asymmetric shape, this tree has little aesthetic value.

I recommend that this tree is felled and re-placed with a smaller flowering specimen that will not conflict with the adjacent yew trees. Suitable replacements would be, *Prunus incisa* 'The Bride', *Prunus* 'Snow Goose' or *Pyrus calleryana* 'Chanticleer'.

If retention of this tree is preferred then instead, prune out the new shoot growth from past pruning points on the south and eastern sides of the canopy, also remove the upright water shoots.

These are advisory works only which are recommended for general tree management rather than for risk management purposes. There is no timeframe for carrying out advisory works.
