### CCTV Survey - Foul Drainage System

#### General overview

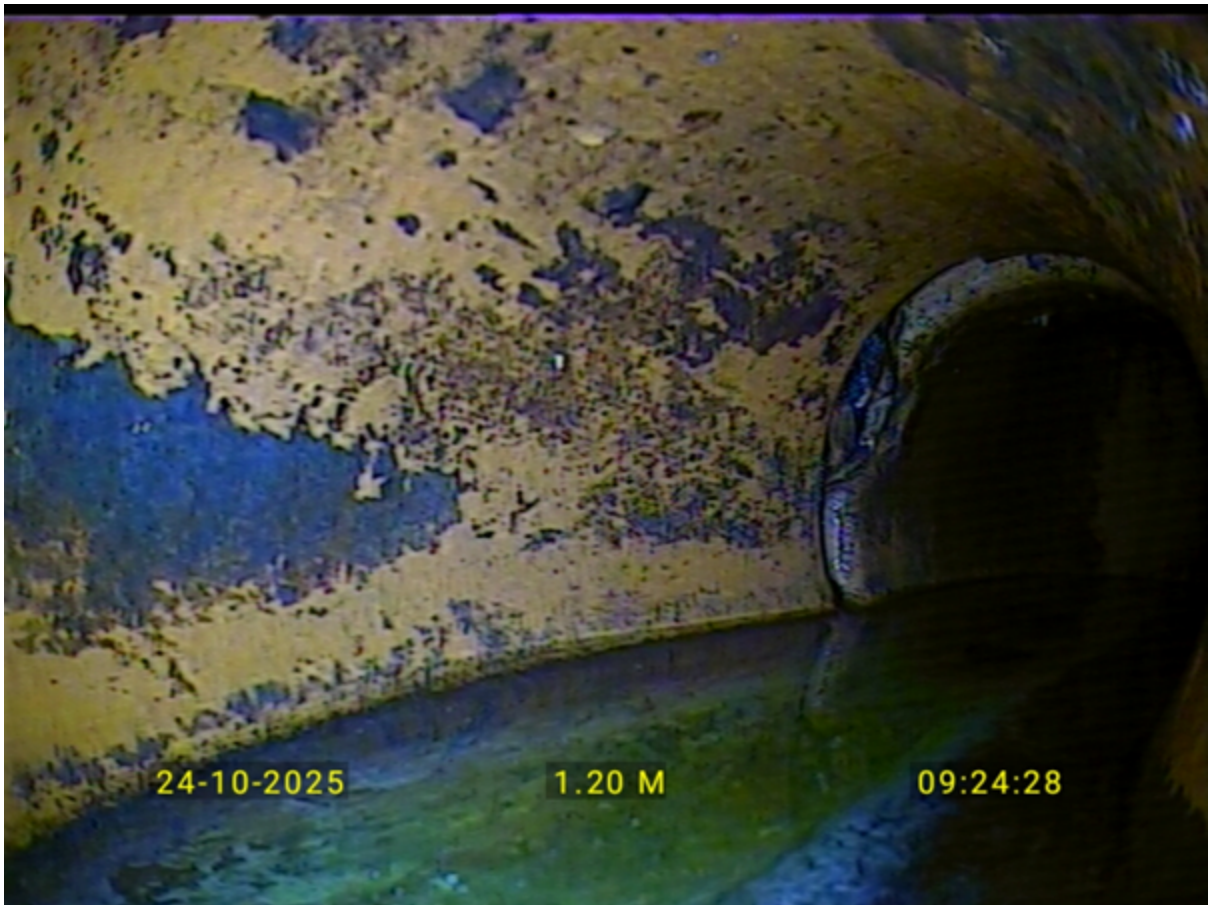
There were some misaligned joints noted with standing water which points to insufficient falls and pipes dropping, in the chamber there was a blockage upon removing the cover this could be put down to insufficient flush on the gents' toilets as well as heavy scaling causing the waste to catch and not flow through smoothly.

There were some misaligned joints and standing water in the disabled pipe run, which may point to insufficient fall.

The current foul drainage system is in a reasonable condition but will require some minor work to be undertaken. Initially the system will require high pressure jetting to remove the scale build up to ensure a smooth run through the pipe runs preventing waste and tissue catching and reducing the chances of blockages. To prevent major excavations to be undertaken, lining of the pipes could be carried out where required to seal the misaligned sections and generally strengthen the system.

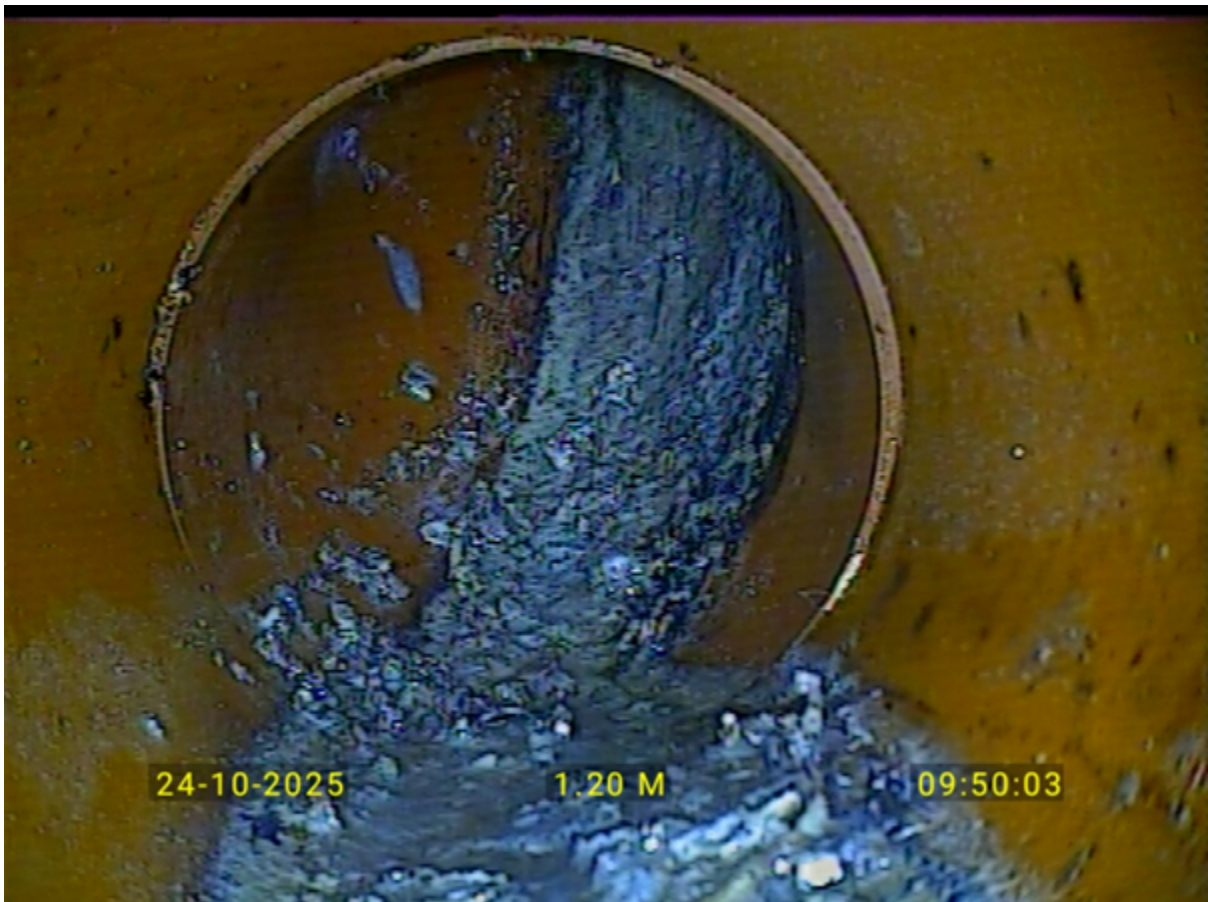
Scale in urinal pipe

A program of routine maintenance/jetting will keep the system in a good condition and will prevent scale build up from becoming a major issue.

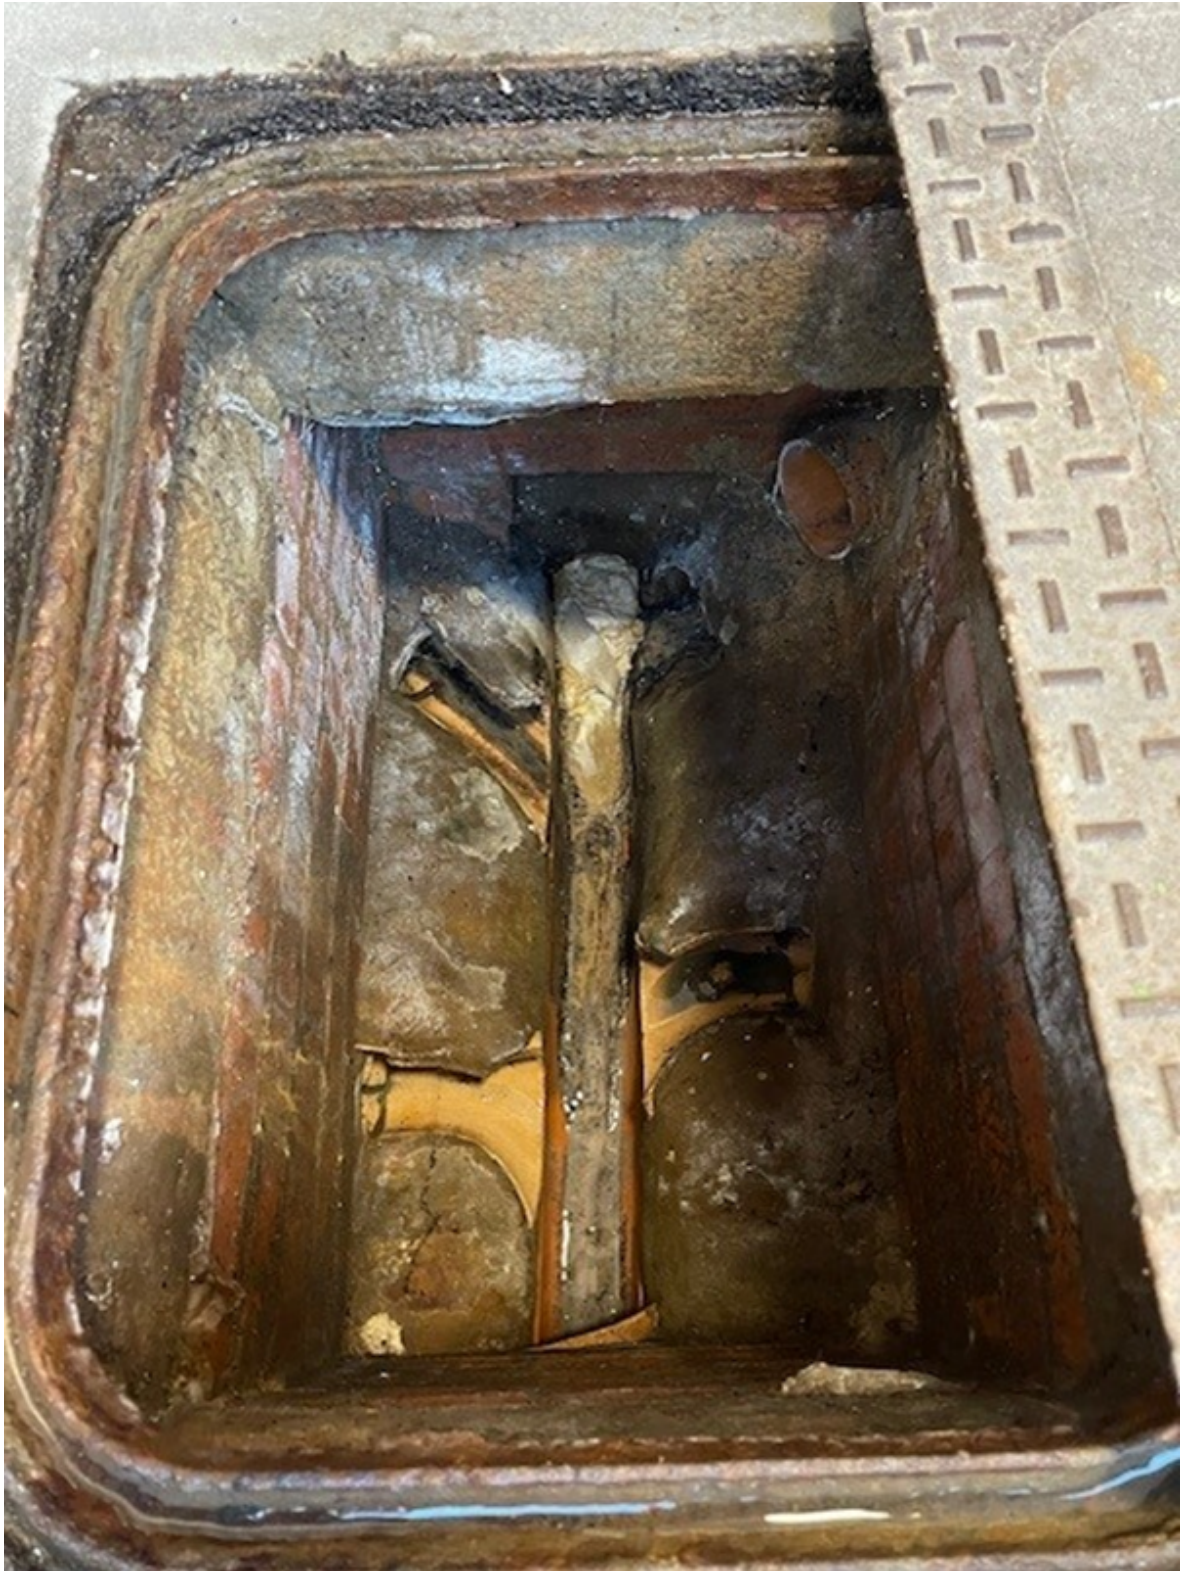
Inspection Chamber with blockages

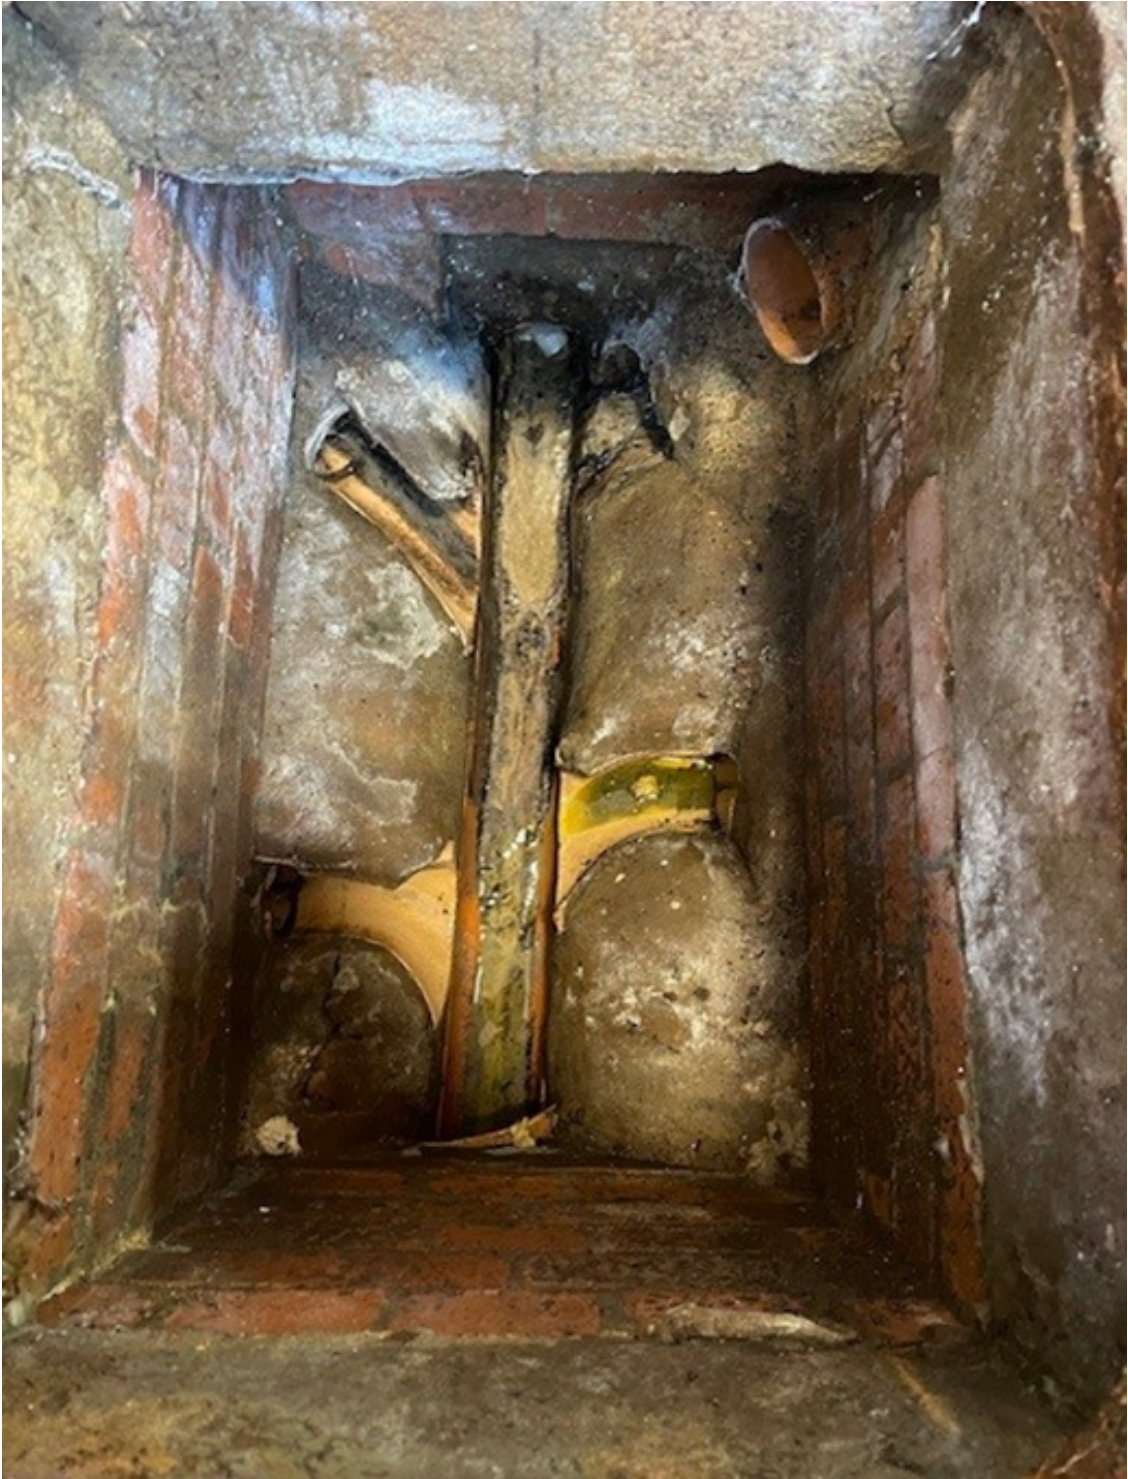
Blockage clear and showing heavy scale

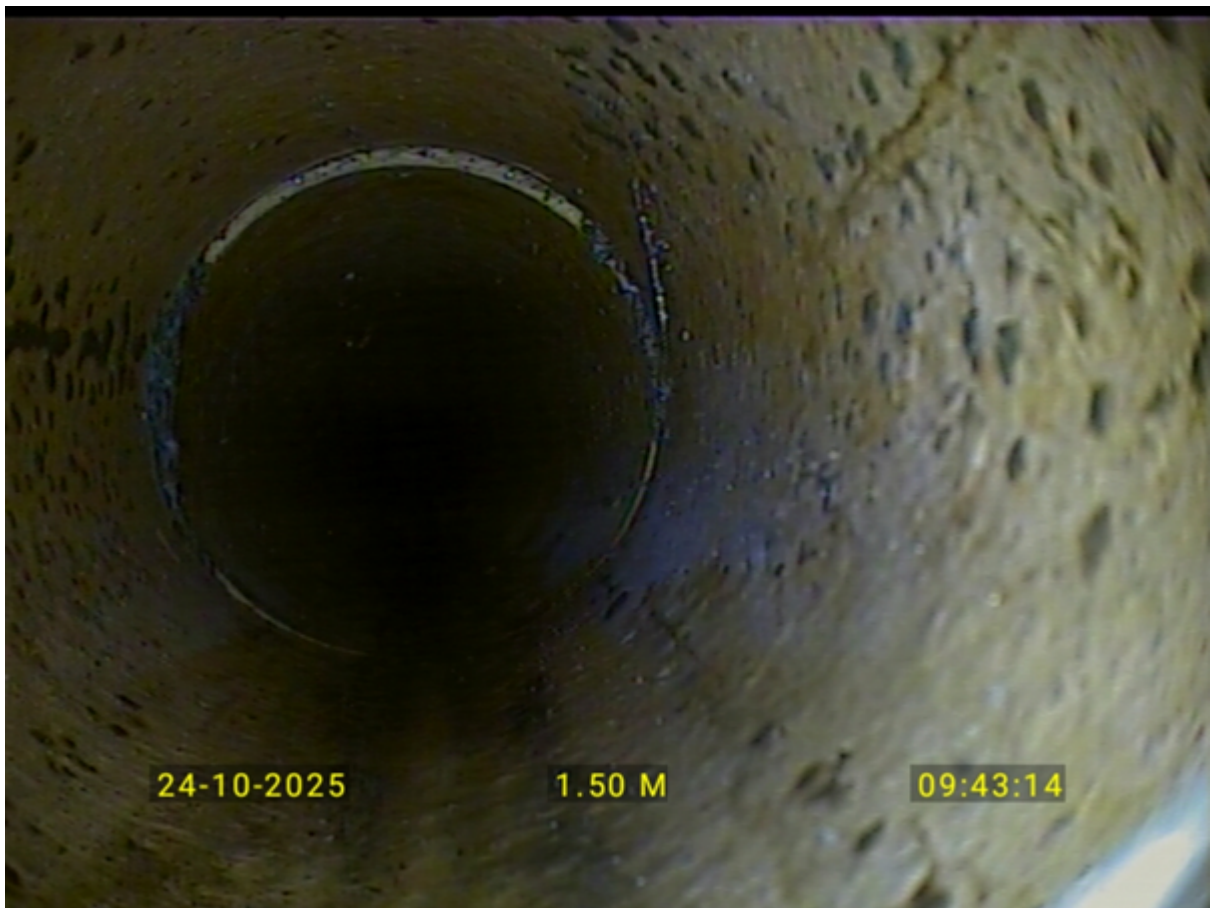
Minor misalignment on gents basin run

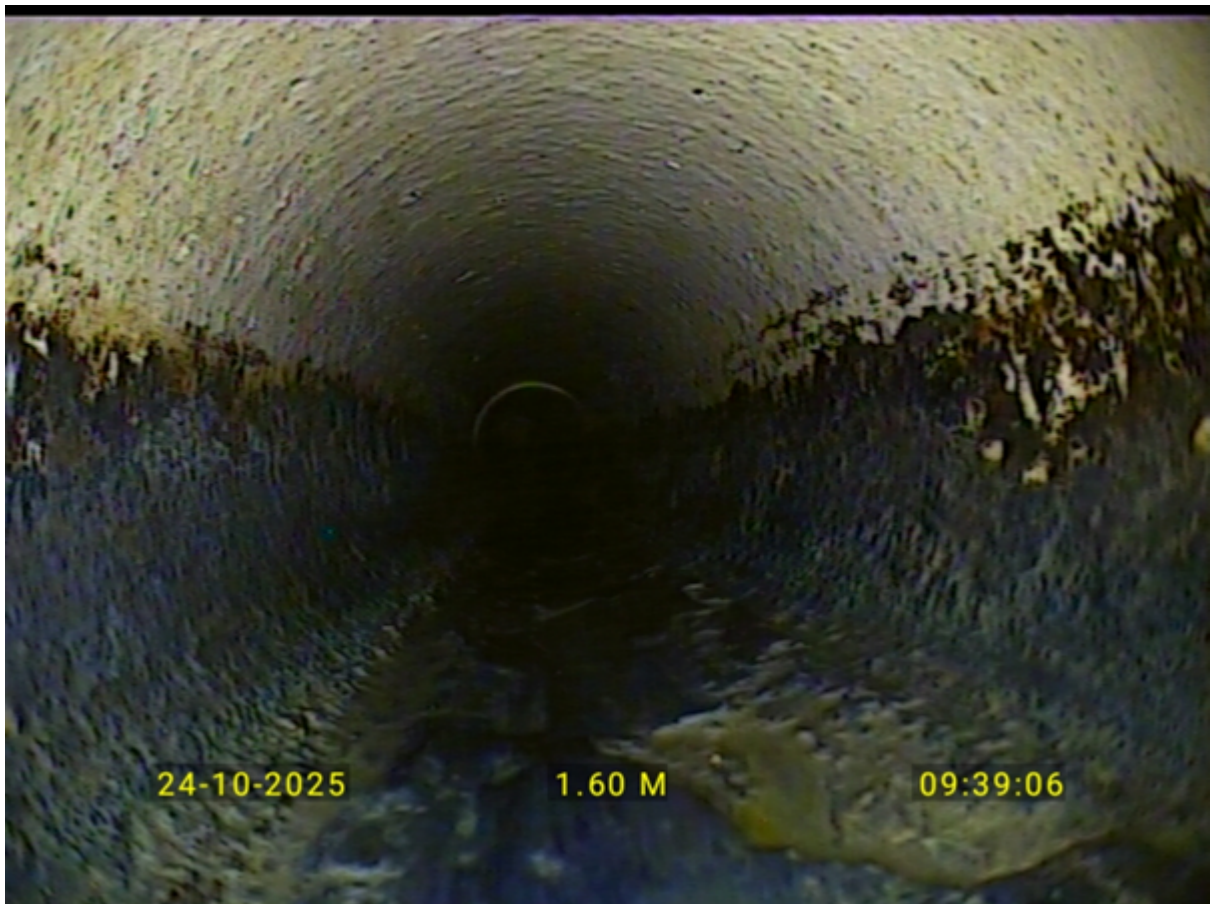
Heavy scale on urinal pipe run

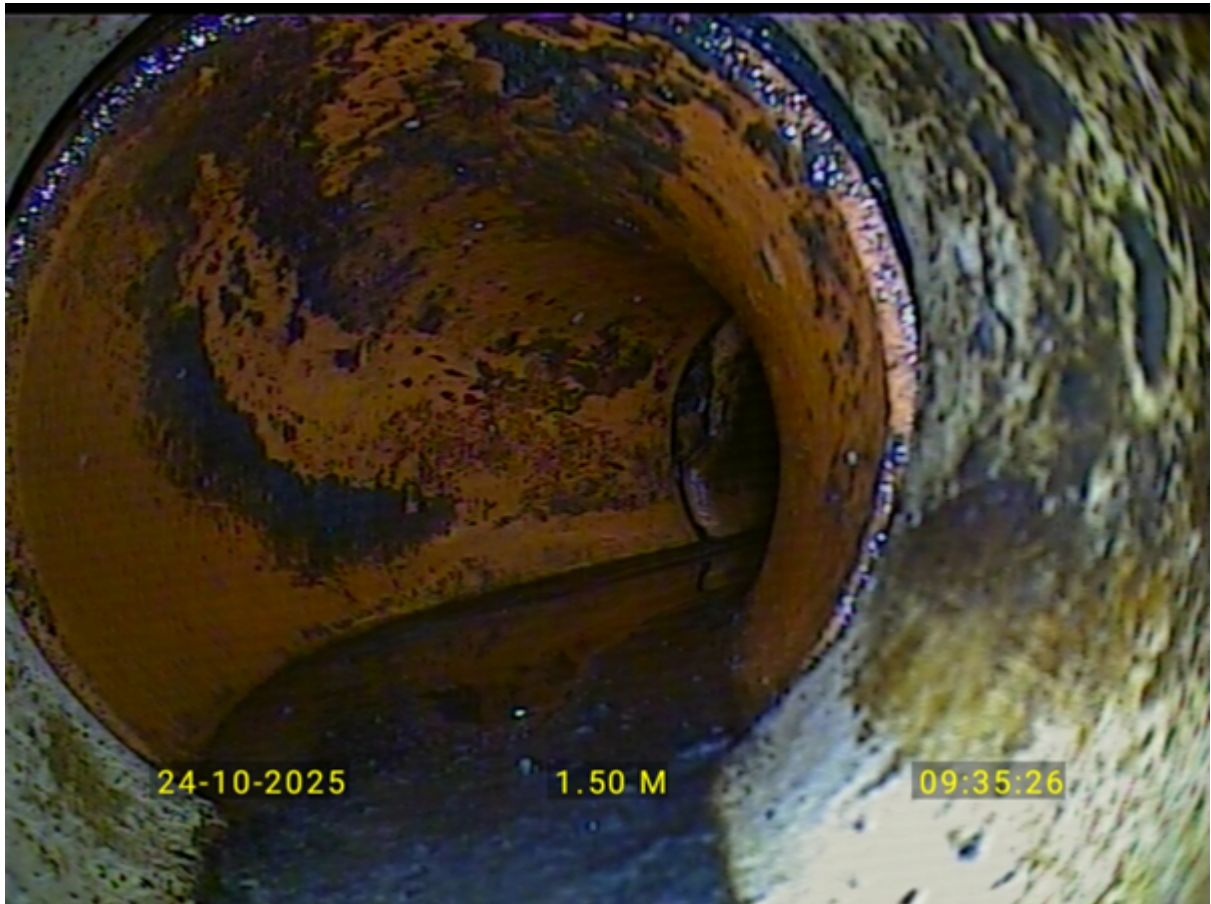
Misaligned pipe with standing water in disabled/ladies

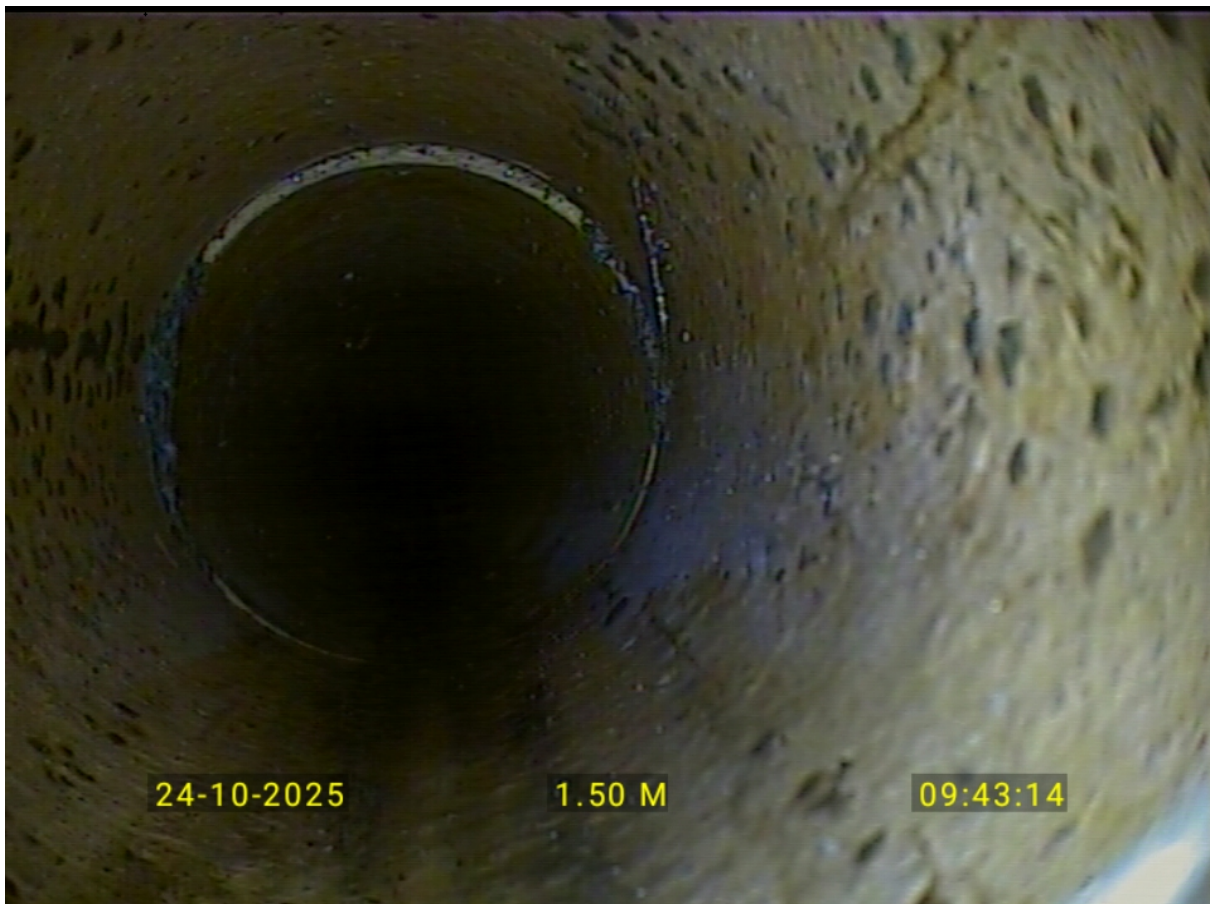
Misaligned pipe on gents basin run

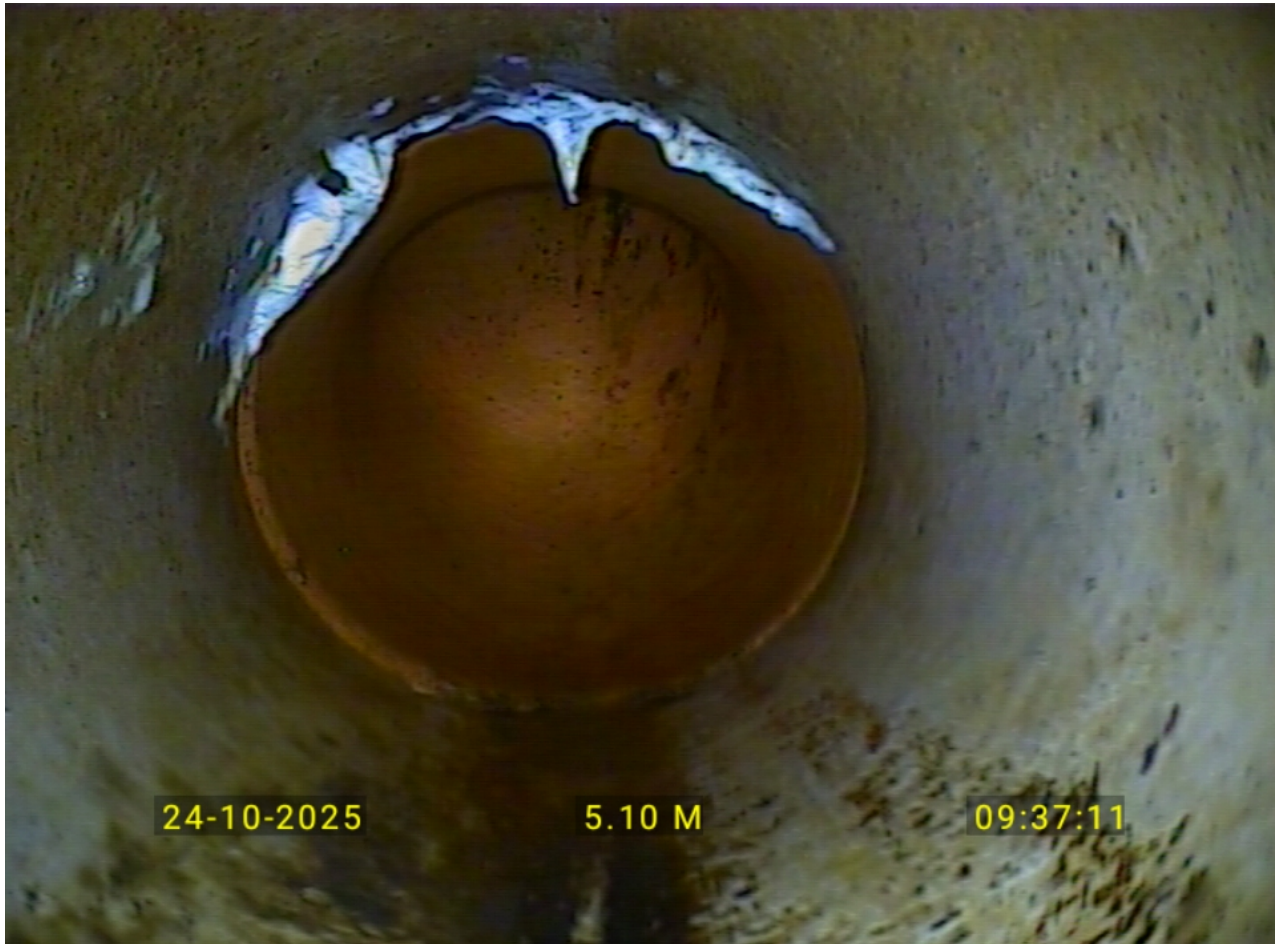
Misaligned joint in gents toilet line

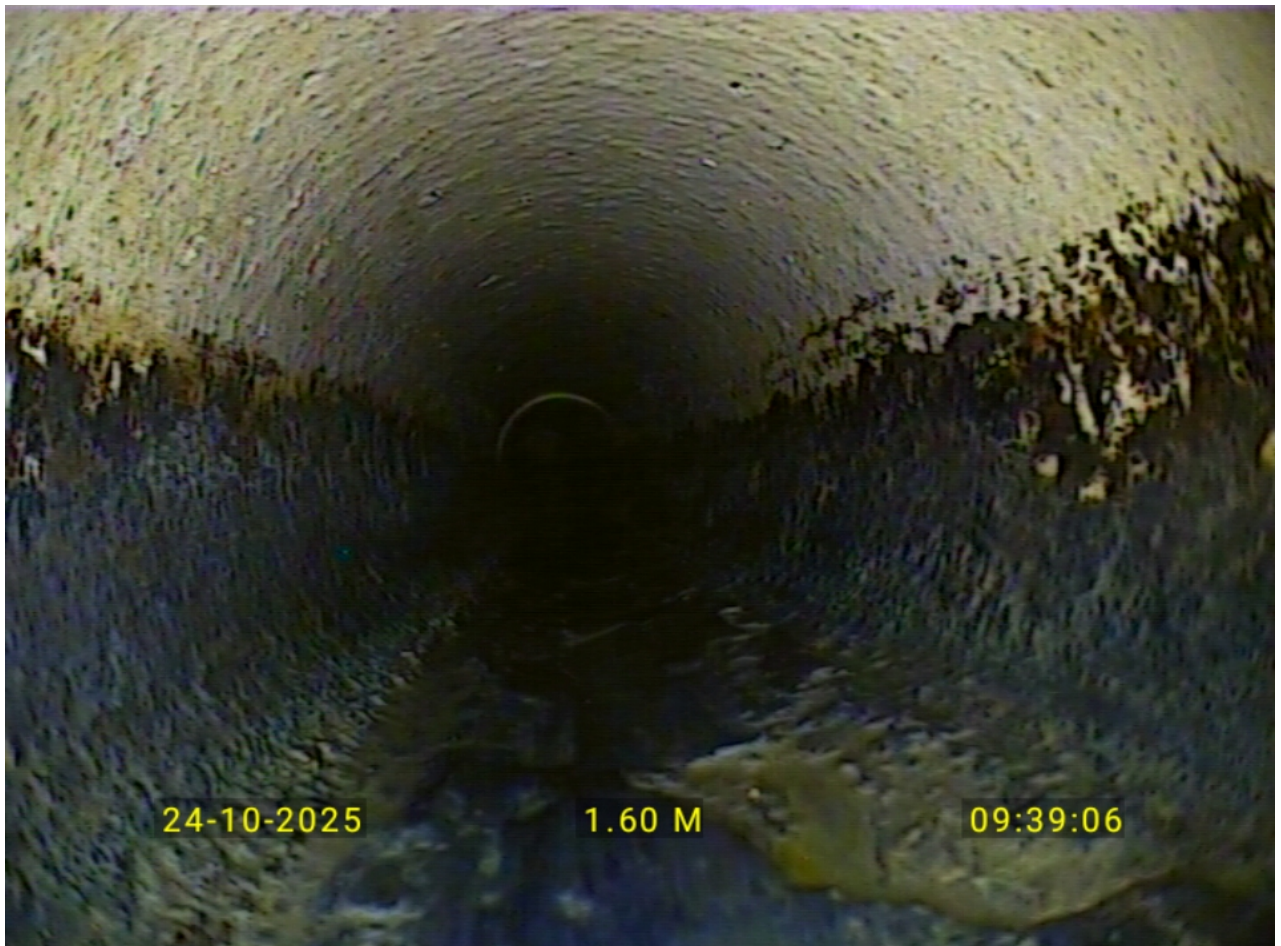
Scale build-up shown in gents toilet run

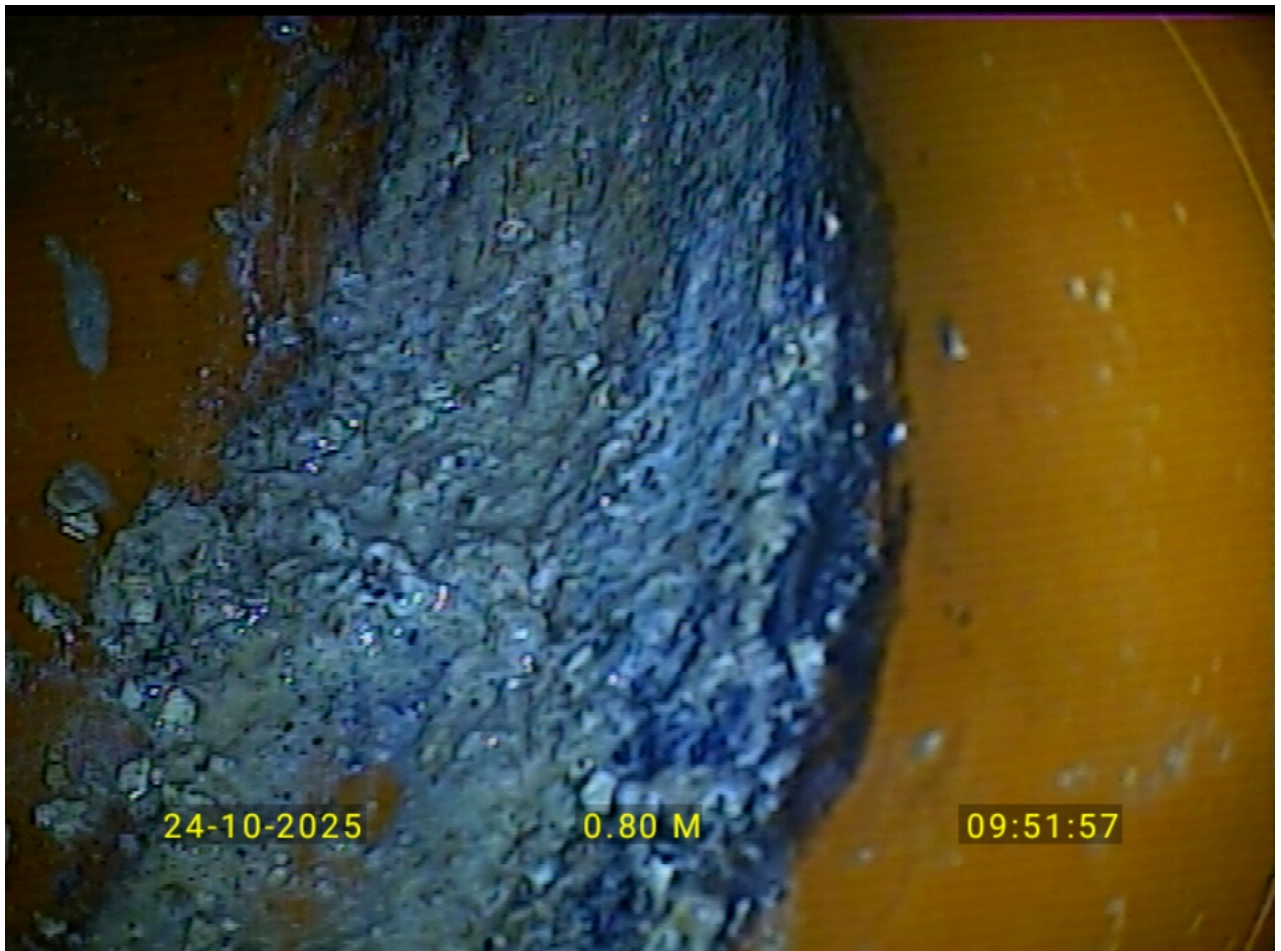
Urinal run - Unable to pass

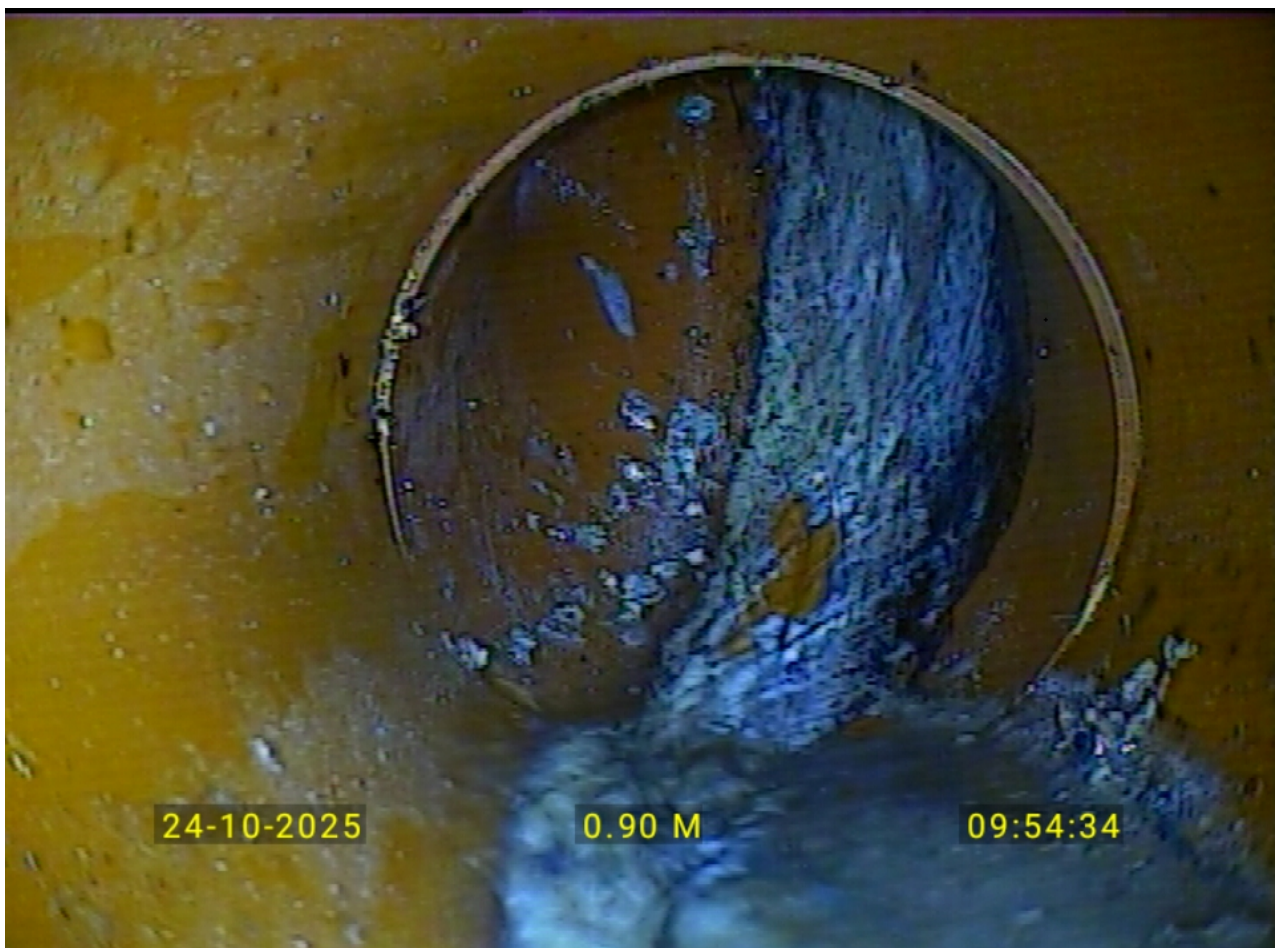
Urinal Flush
