## Asbestos Demolition/Refurbishment Survey

**Public Toilets  
Greyhound Lane  
Wilton  
SP20HT**

Survey Overview	
Survey Type	Refurbishment & Demolition
Survey Purpose	Prior to Refurbishment Works
Date/Time	29/10/2025
Surveyor	Richard Hitchcock

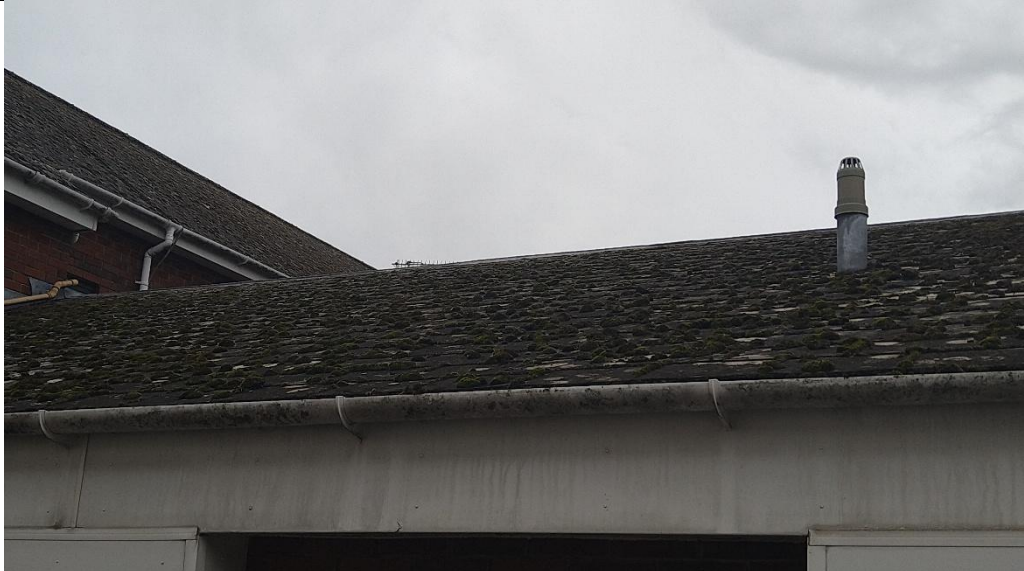
<b>Client</b>			
<b>Survey Address</b>	Public Toilets, Greyhound Lane, Wilton, SP20HT		
<b>Location/Item</b>	E01 Externals/Asbestos Cement Roof Tiles		
<b>Reference Number</b>	2		
<b>Sample Number</b>	2		
<b>Photo Details</b>

<b>Asbestos Type</b>	<b>1</b>	<b>Product Use</b>	<b>1</b>
<b>Condition</b>	<b>1</b>	<b>Surface Treatment</b>	<b>1</b>
<b>Material Risk</b>	<b>4</b>	<b>Action</b>	<b>RIA</b>
<b>Accessibility</b>	<b>Low</b>		
<b>Amount/Extent</b>	<b>65M2</b>		
<b>Surveyors Notes</b>

Remove Asbestos If Affected by Refurbishment Works

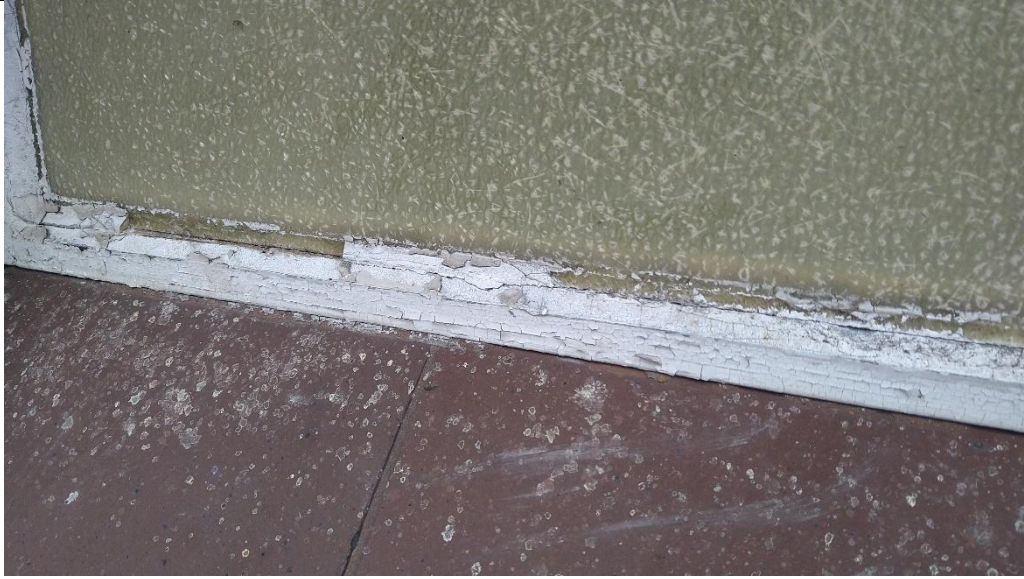
<b>Client</b>	
<b>Survey Address</b>	Public Toilets, Greyhound Lane, Wilton, SP20HT
<b>Location/Item</b>	E01 Externals/Window Putty
<b>Reference Number</b>	3
<b>Sample Number</b>	3
<b>Photo Details</b>
