5005D – Wilton Flow and Erosion ECI Technical Report.

**Document title** - Wilton Flow and Erosion – ECI Technical Report

**Client** - Wilton Town Council

FiveRivers has been commissioned by Wilton Town Council to carry out a technical walkover survey and prepare a report on the condition of the River Wylde and its various tributaries as they flow through the town of Wilton.

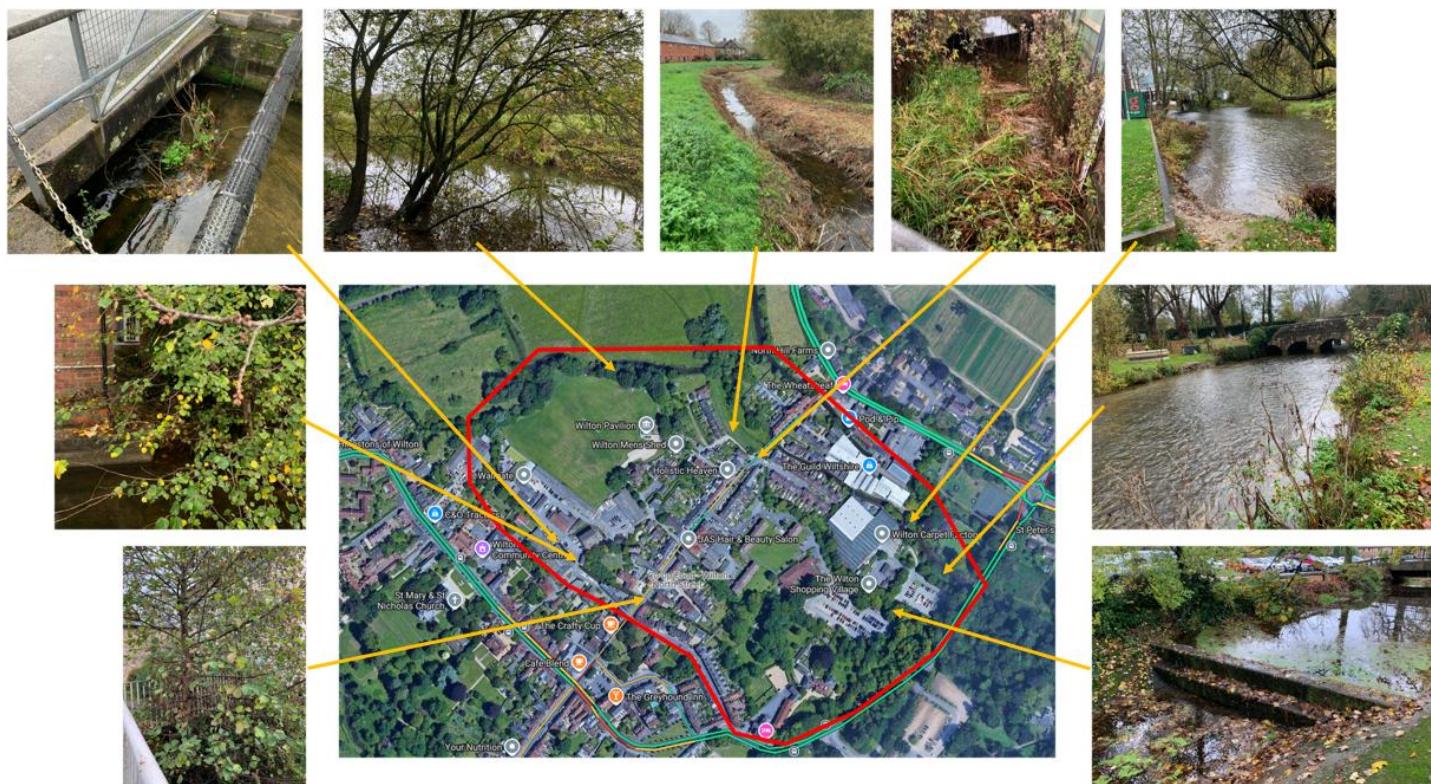
Figure 1: Site Location Areas

Several locations within the Wilton catchment area of the River Wylde were assessed. The image below highlights the key areas examined as part of the environmental assessment.

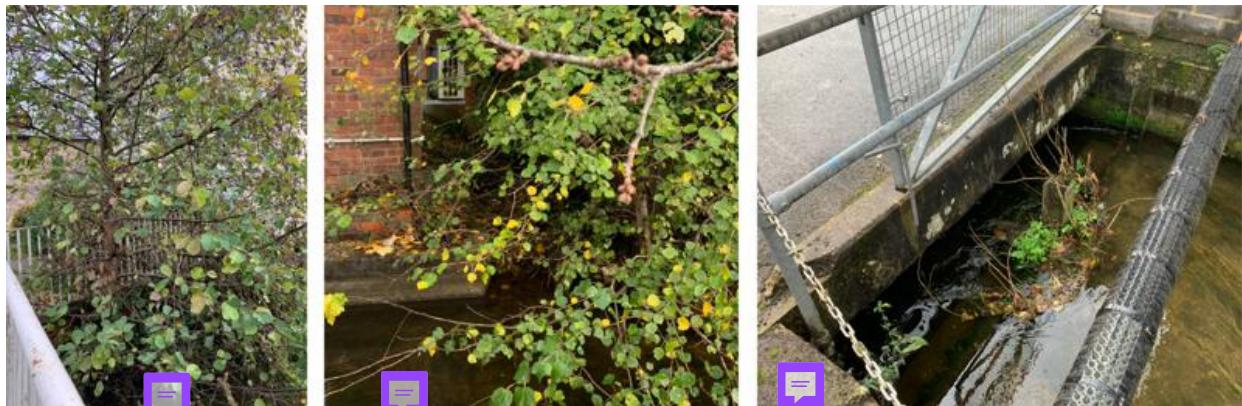
The road bridge adjacent to Crow Lane exhibits significant vegetation growth, including an alder tree located at the downstream end of the bridge. During periods of high flow, this vegetation is likely to restrict water movement and impede the free passage of flow beneath the structure.

Further downstream the channel exhibits similar vegetation growth which will restrict water movement further.

Further upstream along Crow Lane, a high flow channel was observed. This channel was likely originally designed to convey flows during high water or flood events. However, during the site visit, it was noted that the channel is heavily obstructed by debris, vegetation, and tree growth at its downstream end where it connects with the main channel. These blockages are likely to limit its hydraulic capacity and effectiveness during flood conditions.

A redundant weir was observed in the Crow Lane area, causing an accumulation of debris upstream. This obstruction is creating a localised difference in water levels of approximately 100mm. The weir no longer serves a functional purpose and is contributing to an increased flood risk by allowing debris to collect, which could exacerbate flooding to surrounding areas during high flow events. Removal or modification of this structure is recommended to restore natural flow and reduce associated risks.

Figure 2: Images left to right. Road bridge adjacent to Crow lane, Crow lane High level channel blocked, Crow lane redundant weir.

Alder tree and dense vegetation at the downstream end of the bridge could restrict flow during high water events. Potential for debris accumulation against the bridge, increasing localised flood risk and reduced hydraulic efficiency under the bridge during peak flows.

Obstructions from vegetation, debris, and tree growth may reduce channel capacity during flood events and increased risk of upstream flooding if high flows cannot be conveyed effectively.

Creates a localised water level difference (approx. 100mm) and traps debris, which is no longer functional, contributing to elevated flood risk for surrounding properties.

Obstruction may exacerbate upstream flooding during high flow **events**.

Based on the observed risks, including vegetation encroachment at the bridge, blockage of the high level channel, and debris accumulation around a redundant weir. It is recommended that regular vegetation management be undertaken, with overhanging and channel vegetation, particularly alder trees near the bridge, routinely trimmed or removed to maintain unobstructed flow.

A scheduled maintenance programme should also be implemented to minimise debris build up. The high level channel should be cleared of accumulated debris, trees, and invasive vegetation to restore its intended hydraulic capacity during flood conditions.

In addition, the redundant weir should be modified or removed to re-establish natural flow conditions and reduce upstream water level variation, ensuring that all removed material is safely disposed of and monitoring is carried out for any downstream sediment movement.

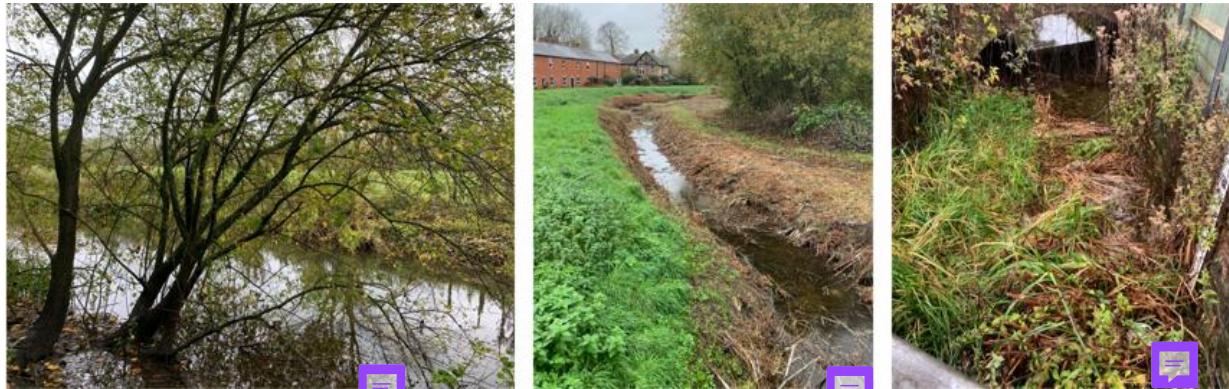
During the walkover at Wilton Meadows, several medium to large willow trees were observed along the banks of the River Wylde. These trees pose a potential future risk of falling into the channel and becoming established within the watercourse, which could restrict flow and reduce channel capacity. While a limited amount of fallen or marginal vegetation can provide ecological benefits and does not significantly impact flow, ongoing maintenance will be required to prevent excessive accumulation of fallen trees or debris that could lead to blockages.

Further downstream, an artificially created high flow relief channel designed to run adjacent to Wiley Ter was found to have little to no observable flow. This lack of movement is likely due to a downstream obstruction identified later in this report, a weir with an abnormally high crest level. The gradient of the tributary is minimal, and dense vegetation growth within the channel further contributes to the reduction of flow velocity and conveyance.

Downstream of the road bridge adjacent to Wiley Ter, vegetation has become established across the full width of the channel due to prolonged low flow conditions. This excessive growth is restricting flow, reducing conveyance capacity, and increasing the risk of localised flooding during high water events.

Figure 3: Images left to right. Wilton Meadows Overhanging Willow, Wiley Ter high channel, Downstream of Wiley Ter

Medium to large willow trees could fall into the channel, causing blockages and restricting flow and potential for future bank destabilisation if root systems fail or trees topple.

Obstruction from downstream weir limits water conveyance, reducing hydraulic efficiency. Also, the noted minimal channel gradient and dense vegetation slow flow, increasing risk of upstream flooding. Along with the accumulation of debris in stagnant areas may further impede flow.

Full width vegetation growth reduces channel capacity and increased likelihood of localised flooding during high flow events. Also allows for potential for debris entrapment, worsening flood risk.

Given the observed risks overhanging willow trees, reduced low flow capacity in the relief channel due to a high downstream weir, and vegetation growth restricting flow downstream of the bridge. It is recommended that a proactive tree management approach be adopted, involving the monitoring and selective pruning or removal of medium to large willow trees to prevent potential blockages while retaining ecological value through a structured maintenance plan.

Improvements to the relief channel should include assessing and modifying the downstream weir to enable more effective low flow conveyance, alongside clearing vegetation and debris to restore hydraulic efficiency.

Additionally, vegetation downstream of the bridge should be periodically cut or managed across the full channel width to maintain capacity, using methods such as marginal planting or controlled vegetation zones to ensure an appropriate balance between ecological benefits and hydraulic performance.

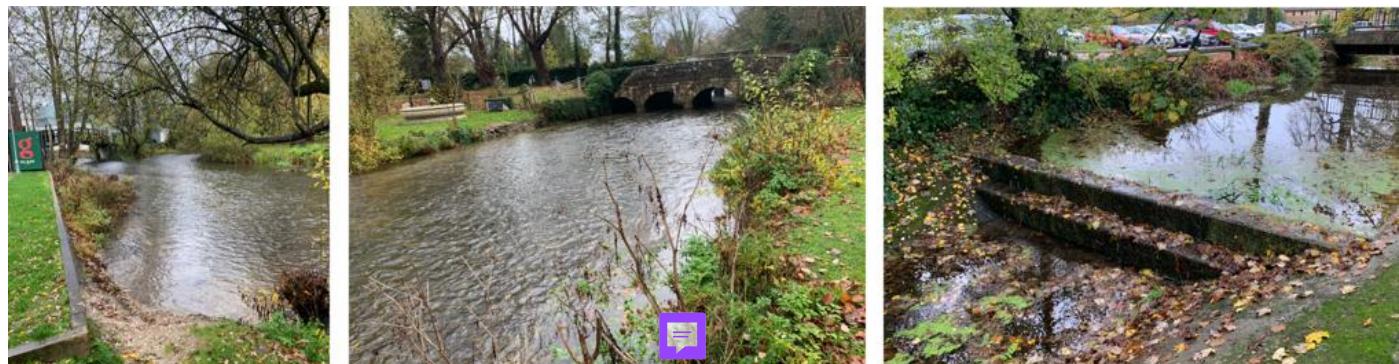
Upstream of the Guild Shopping Centre entrance, debris was observed within the river channel, along with localised areas of bank erosion. These erosions correspond with the remnants of a previously installed revetment, which has deteriorated, leaving only some upright posts in place.

Further downstream, towards the A30, similar patterns were observed. The original revetment has largely diminished, and additional erosion along the banks has been caused by wildlife, public access, and domestic animals. Several willow trees are also establishing along the banks; these will require management to prevent them from dominating the channel margins and further restricting flow.

The connecting channel from Wiley Terrace contains a substantial weir, approximately 800mm in height, which significantly restricts downstream flow. This obstruction results in minimal water movement in the channel, causing debris and sediment to accumulate. Consequently, the restricted flow increases the risk of flooding to upstream properties during high flow events. Addressing this area presents a key opportunity for flood alleviation and improving overall channel efficiency.

Figure 4: Images left to right. Wilton Guild Shopping centre, River Wylye upstream of A30 Road Bridge, Weir on River Wylye Channel from Wiley Ter.

Localised erosion of banks reduces channel stability and may contribute to sedimentation downstream, along with remnants of deteriorated revetment provide limited protection, increasing risk of further bank failure.

Loss of revetment and erosion from wildlife, public use, and domestic animals. Along with establishing willow trees could dominate banks, reduce channel conveyance and increase flood risk.

Significant restriction to flow, causing debris accumulation and minimal water movement. Also, increased flooding risk to upstream properties during high flow events.

Putting into account current observed risks, including debris accumulation, bank erosion with diminished revetments, the establishment of willow trees, and a substantial weir restricting flow. It is recommended that bank stabilisation works be undertaken, repairing or replacing degraded revetments with environmentally sensitive solutions such as bioengineering, pre planted coir rolls, or rock rolls (however have plastic content for the material used to contain the granite rocks), while also introducing protective measures to limit damage from wildlife, domestic animals, and public access.

Willow trees along the channel margins should be pruned or selectively removed to prevent dominance and maintain flow capacity, with consideration given to planting alternative riparian species that provide bank stability without impeding conveyance.

The 800 mm weir on the connecting channel from Wiley Terrace should be modified or lowered to restore more natural flow, reduce debris accumulation, and decrease upstream flood risk, followed by monitoring to ensure improvements do not trigger downstream erosion. This can also be done by introduced a drop board structure in its place to adjust flows according to seasonal water levels.

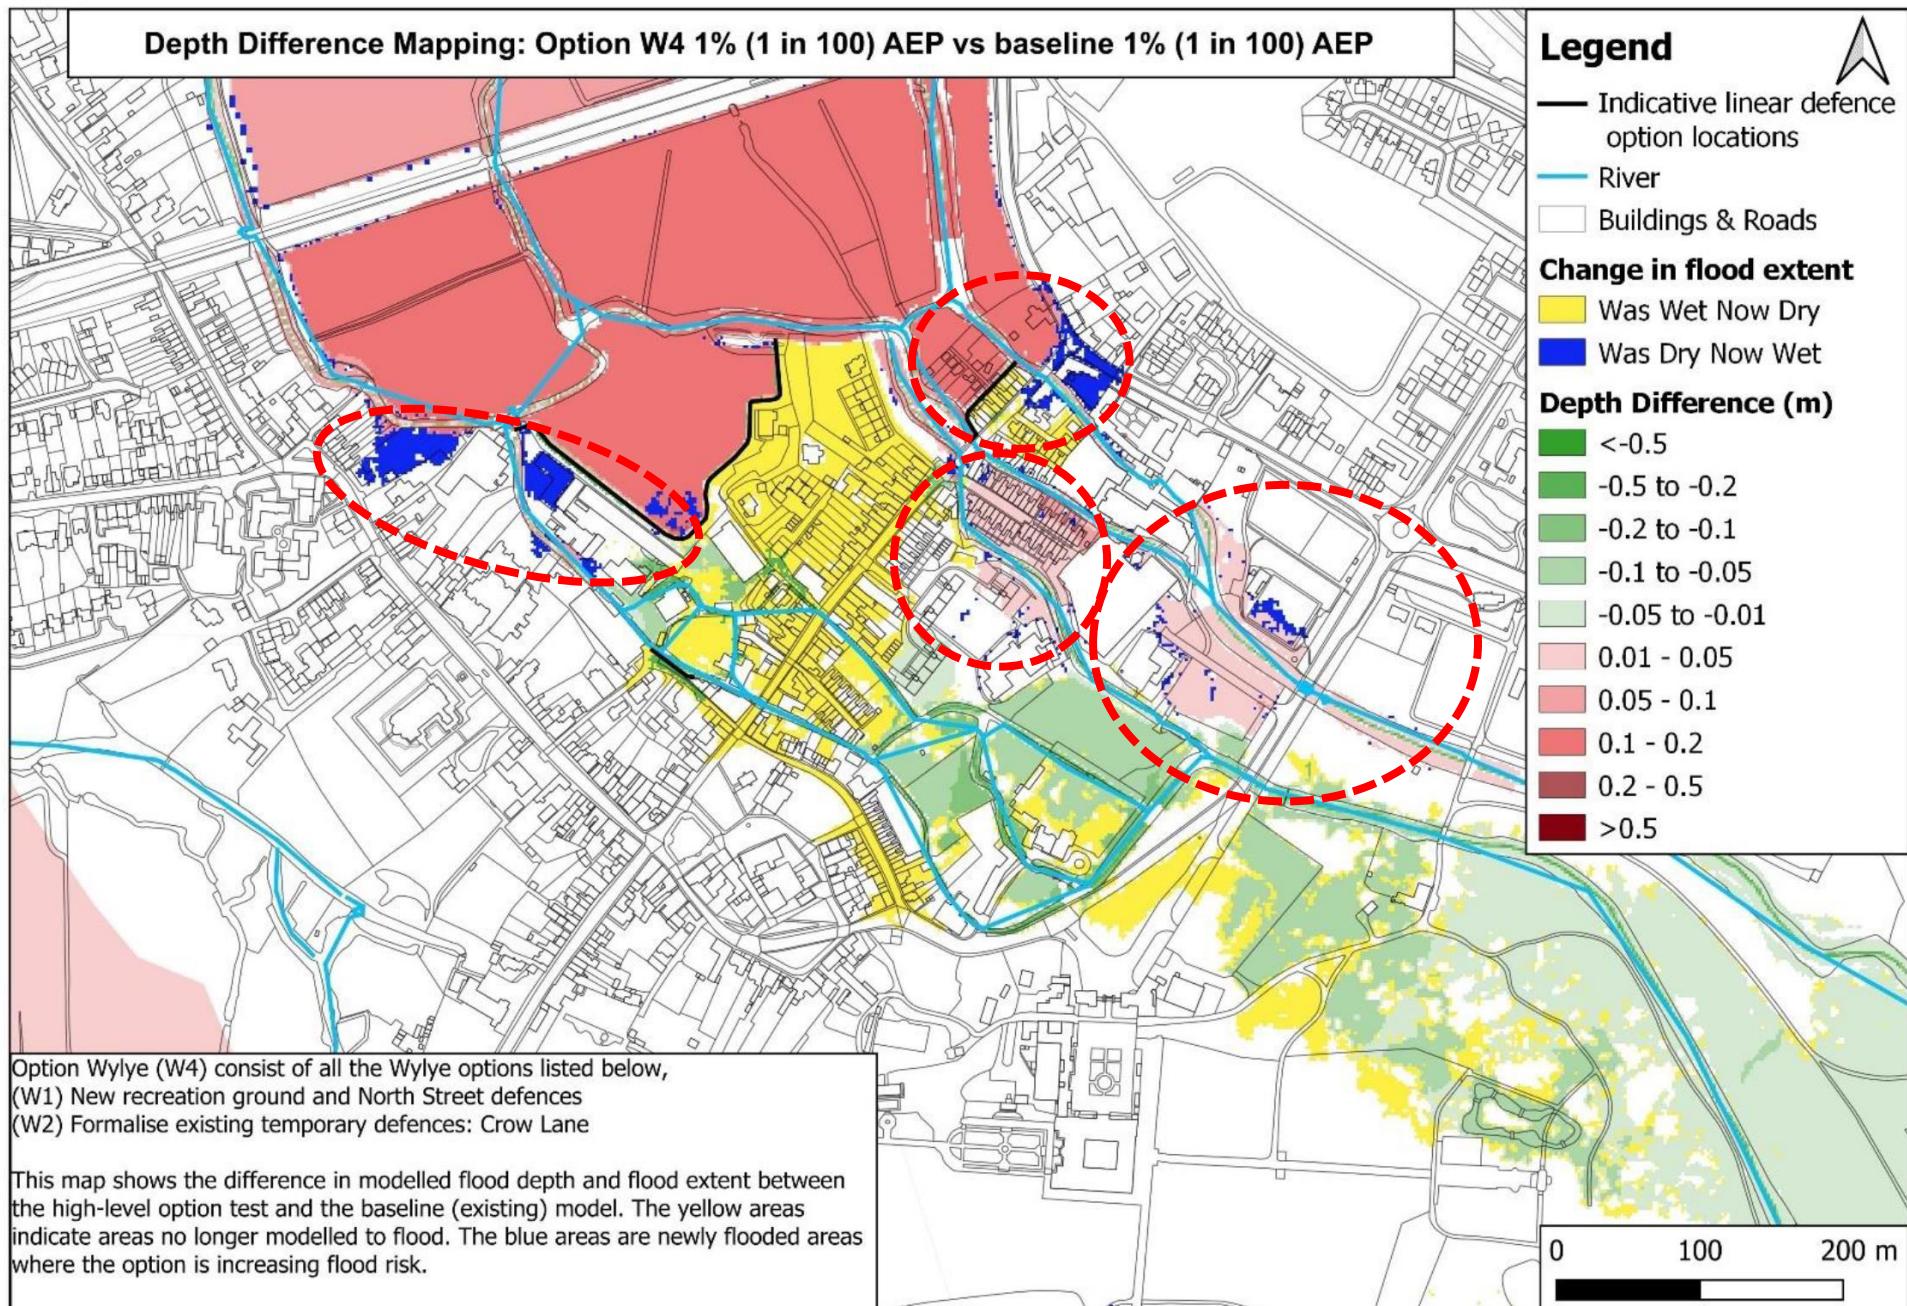
## Figure 2: Areas shown to be dis-benefitting from 2017 scheme

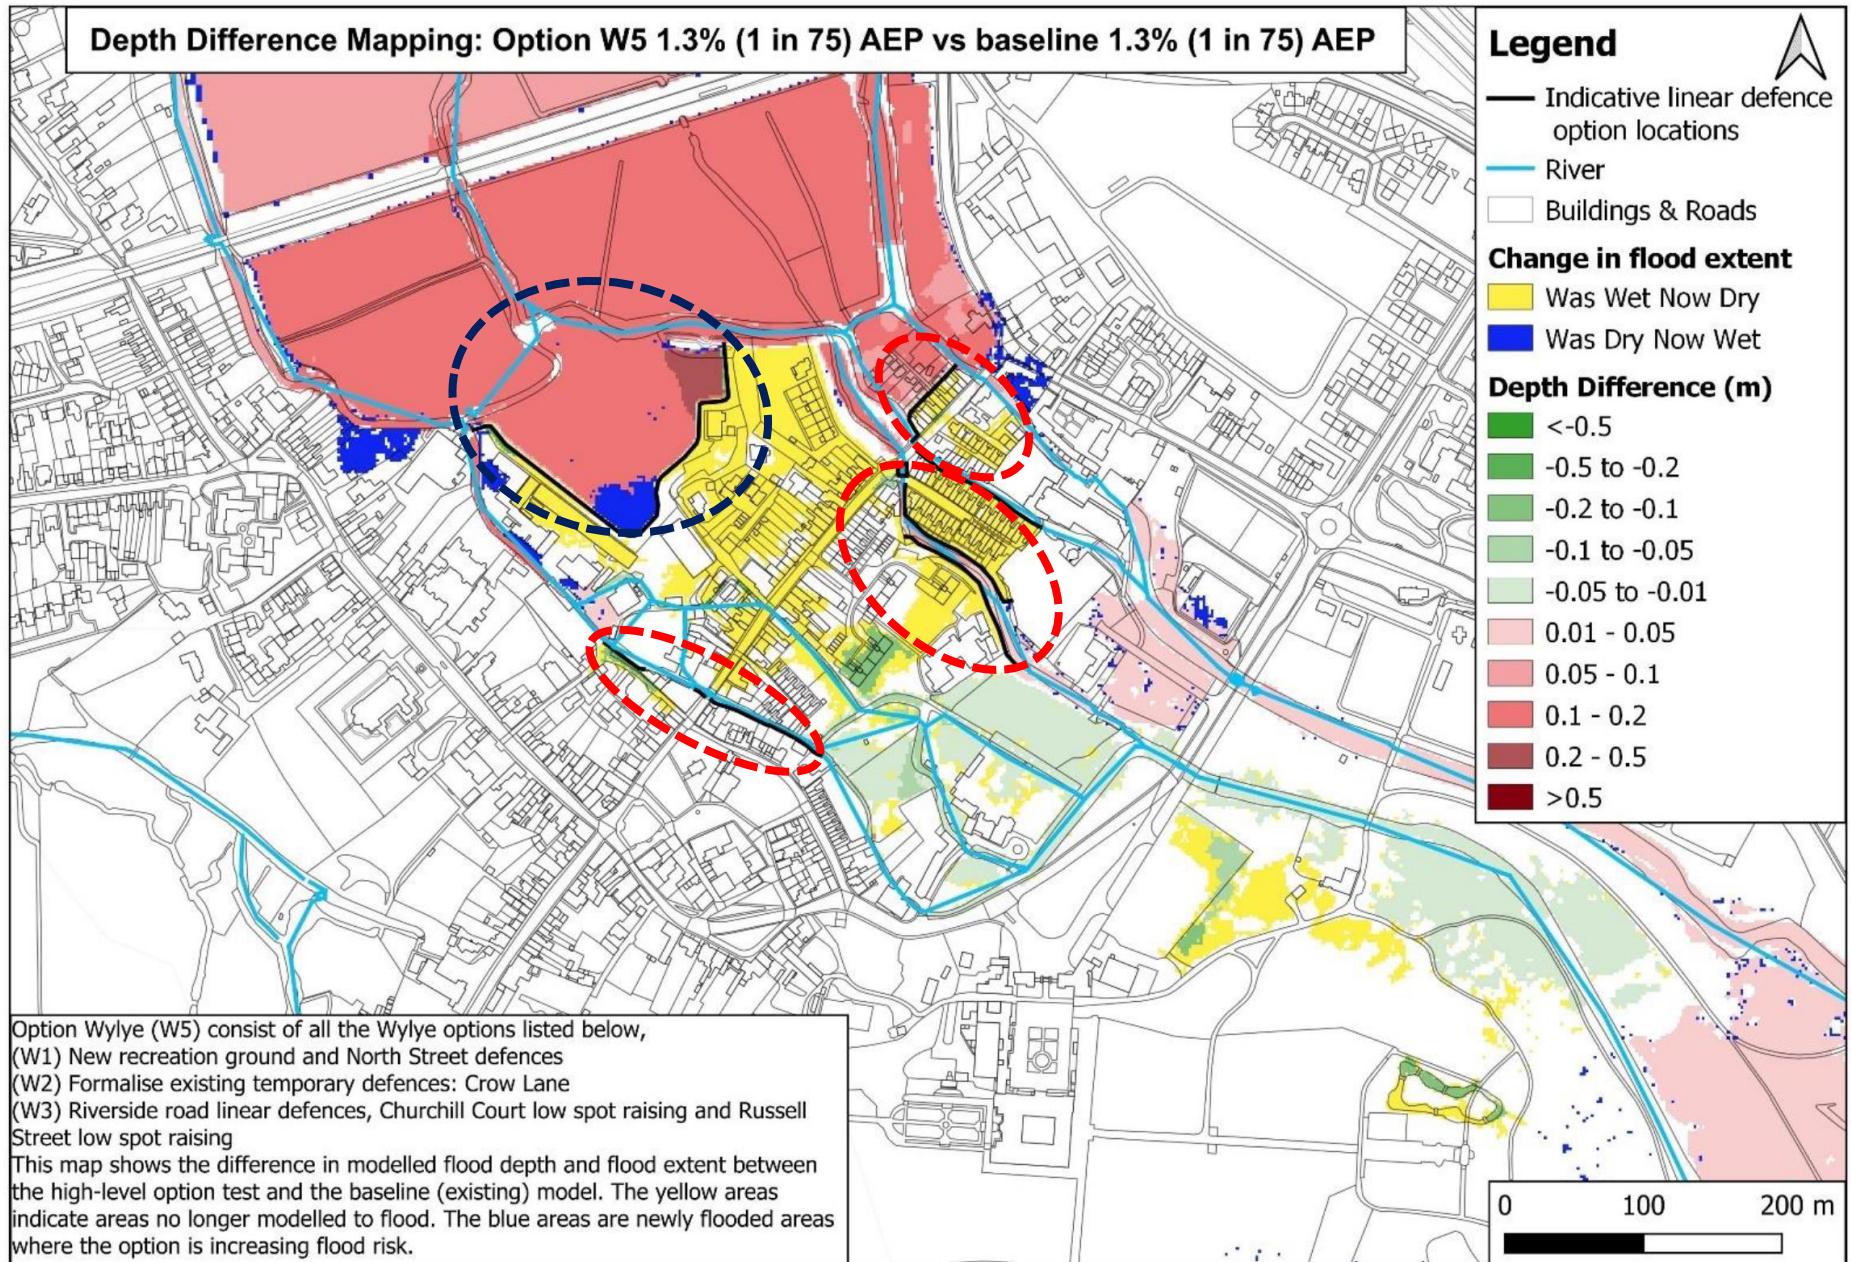
- To reduce the dis-benefit from this scheme additional defences (Figure 3) would be required to keep the river away from properties, and likely to need pumping stations to pick up ground water and surface water.

Figure 3: Areas required to reduce impacts across the whole community
