# Tree Risk Assessment 2026

For two trees on at St. Mary's Church in Wilton

Inspected and Prepared by Nick Baxter BSc(Hons) MArborA  
16<sup>th</sup> March 2026

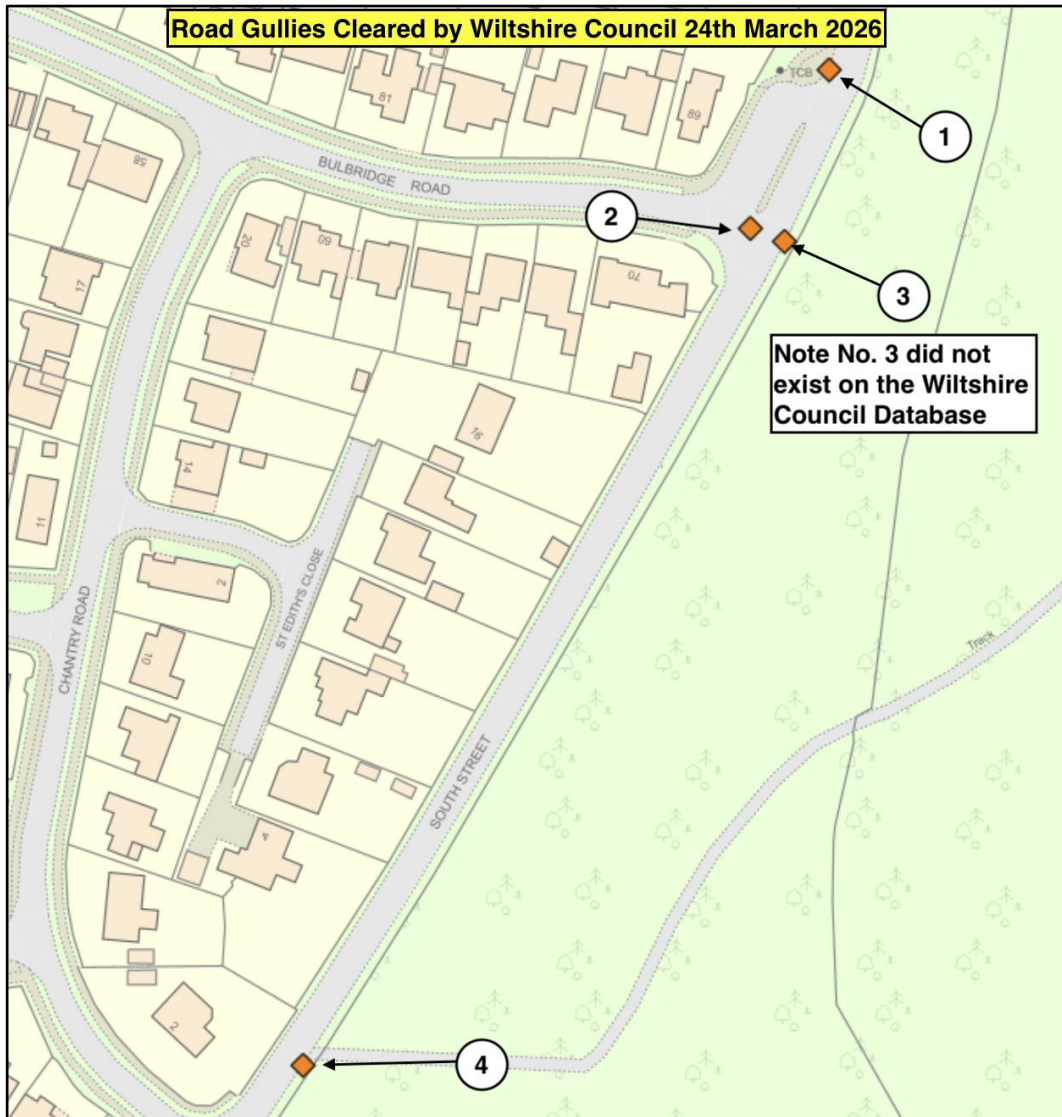
No.	W3W Location	Initial Condition	Cleared	Comments
1	<a href="https://w3w.co/cavalier.starting.pairings">https://w3w.co/cavalier.starting.pairings</a>	Blocked	Yes	
2	<a href="https://w3w.co/rephrase.clerics.shells">https://w3w.co/rephrase.clerics.shells</a>	Blocked	Yes	
3	<a href="https://w3w.co/staked.equipping.screeches">https://w3w.co/staked.equipping.screeches</a>	Blocked	Yes	Not on WC database
4	<a href="https://w3w.co/motorist.shark.describes">https://w3w.co/motorist.shark.describes</a>	Blocked	Yes

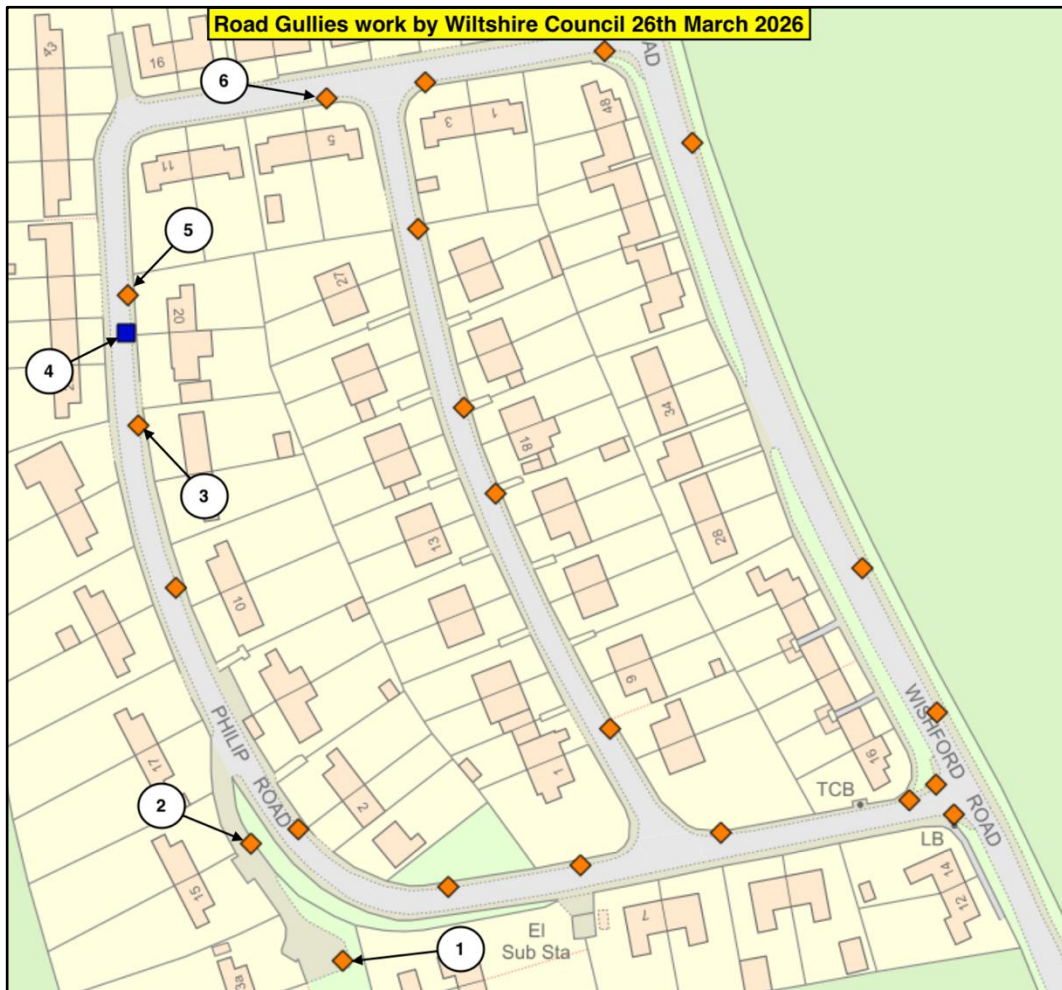
Note these areas were some of the works outstanding from December 2024.

No.	W3W Location	Initial Condition	Cleared	Comments
1	<a href="https://w3w.co/underline.sadly.potions">https://w3w.co/underline.sadly.potions</a>	Blocked	No	Car parked over gully
2	<a href="https://w3w.co/meanings.pretty.multiples">https://w3w.co/meanings.pretty.multiples</a>	Blocked	No	Car obstructing access from Philip Road
3	<a href="https://w3w.co/tablet.pavement.clogging">https://w3w.co/tablet.pavement.clogging</a>	Blocked	Partial	The connecting drain to catchpit is obstructed with roots.
4	<a href="https://w3w.co/irrigated.protected.irritated">https://w3w.co/irrigated.protected.irritated</a>	Blocked	Yes	Catch pit found blocked with roots and outlet from pit blocked after short distance.
5	<a href="https://w3w.co/keener.grafted.interview">https://w3w.co/keener.grafted.interview</a>	Blocked	Yes	Clear between gully & catchpit
6	<a href="https://w3w.co/bulky.unfounded.advice">https://w3w.co/bulky.unfounded.advice</a>	Blocked	Partial	Gully and discharge pipe full of roots. Managed to clear about 2 meters before pipe blocked.
