Legionella Risk Assessment

<p>Wilton Town Council Council Offices, Kingsbury Square Wilton SP2 0BA</p>

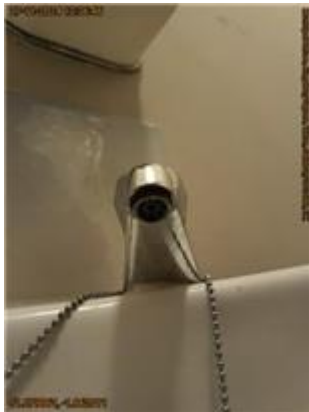
Photo of outlet condition:

Are outlets clean and free from scale and slime?	No – Scale noted on outlets (see the asset register)	<i>Outlets should be cleaned and descaled (including flow restrictors/spray inserts) on a regular basis.</i>
Residual Risk:	MEDIUM = Take actions when operationally practicable
